**Tree Assessment & Preservation Plan
Glen Canyon Park**

Prepared for:
**Recreation & Park Department
City of San Francisco
30 Van Ness Avenue
San Francisco CA 94102**

Prepared by:
**HortScience, Inc.
325 Ray Street
Pleasanton, CA 94566**

October, 2012

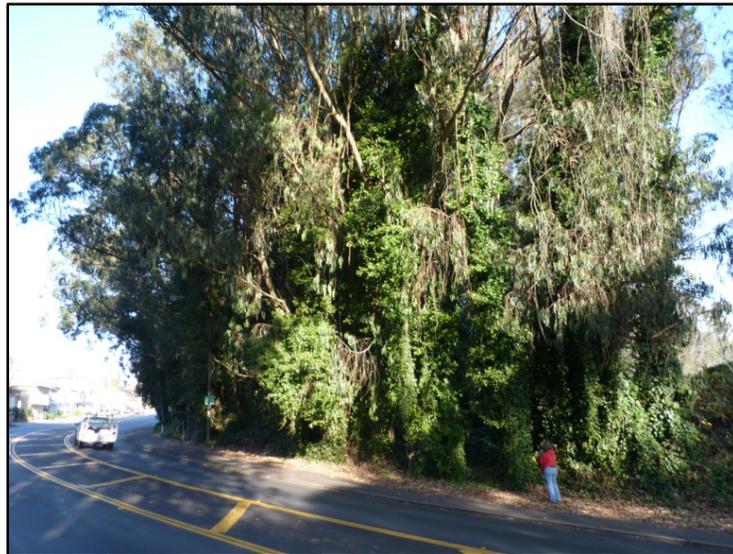
Photo 1. Blue gums #600 to 623 were part of a dense planting along O'Shaughnessy Blvd. Note extensive growth of vines along the trunks.

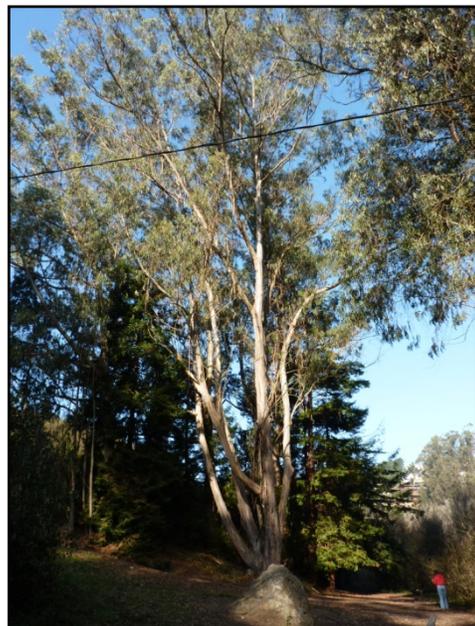
Photo 2. Located in the center of the park, near the pre-school facility, blue gum #625 was 90" in diameter and in fair condition.

617	O'Shaughnessy	E.	Blue gum	25	2	9	Remove tree	Risk rating ≥9
619	O'Shaughnessy	E.	Blue gum	32,28,12,10	2	8	Remove tree	Poor condition
625	Glen Park	Trail	Blue gum	90	3	7	Noted in Trail project report as prune to clean crown & reduce long laterals.	
627	Glen Park	Trail	Blue gum	29,28,25	3	9	Prune to remove 25" stem	Risk rating ≥9

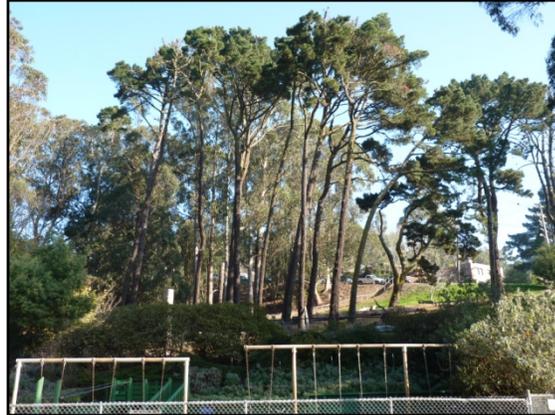
Photo 3. Pines #41 – 57 were generally in poor condition with small high crowns and leaning trunks.
