**Tree Assessment  
South Park**

*Prepared for:*  
**Recreation & Park Department  
City of San Francisco  
30 Van Ness Avenue  
San Francisco CA 94102**

*Prepared by:*  
**HortScience, Inc.  
325 Ray Street  
Pleasanton, CA 94566**

**March 2012  
Updated November 2015**

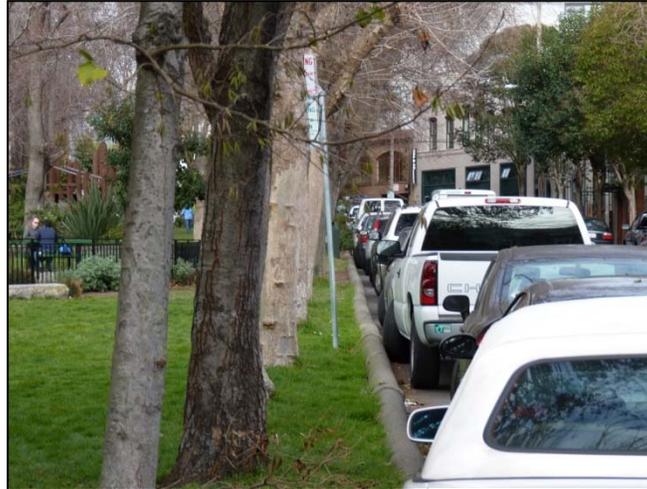
South Park is an elongated oval in form. Almost all trees are planted adjacent to the street within 2' of the curb (Photo 1). There was, however, little apparent displacement of curb and pavement associated with tree roots. Curbing appeared to be worn due to age and weathering.

**Photo 1.** Looking east along south side of park. Note that trees are located within a few feet of the street. But there is little displacement of the curb.
