**Tree Assessment & Management  
Plan  
South Park**

*Prepared for:*  
**South Park Improvement Association  
C/O Levy Design Partners  
90 South Park  
San Francisco CA 94107**

*Prepared by:*  
**HortScience, Inc.  
325 Ray Street  
Pleasanton, CA 94566**

**March 2012**

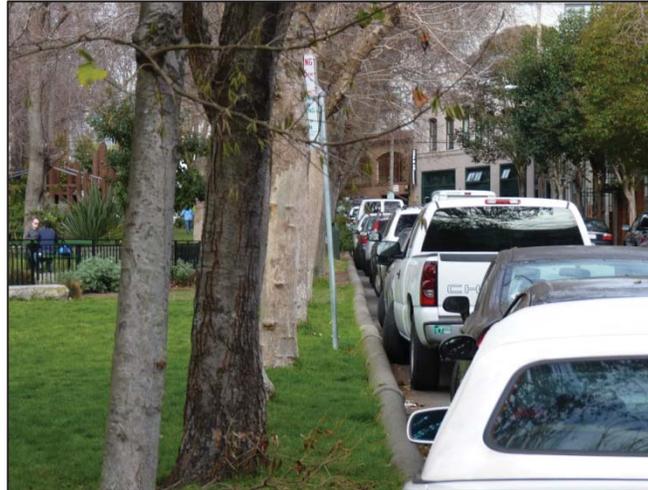
South Park is an elongated oval in form. Almost all trees are planted adjacent to the street within 2’ of the curb (Photo 1). There was, however, little apparent displacement of curb and pavement associated with tree roots. Curbing appeared to be worn due to age and weathering.

**Photo 1.** Looking east along south side of park. Note that trees are located within a few feet of the street. But there is little displacement of the curb.

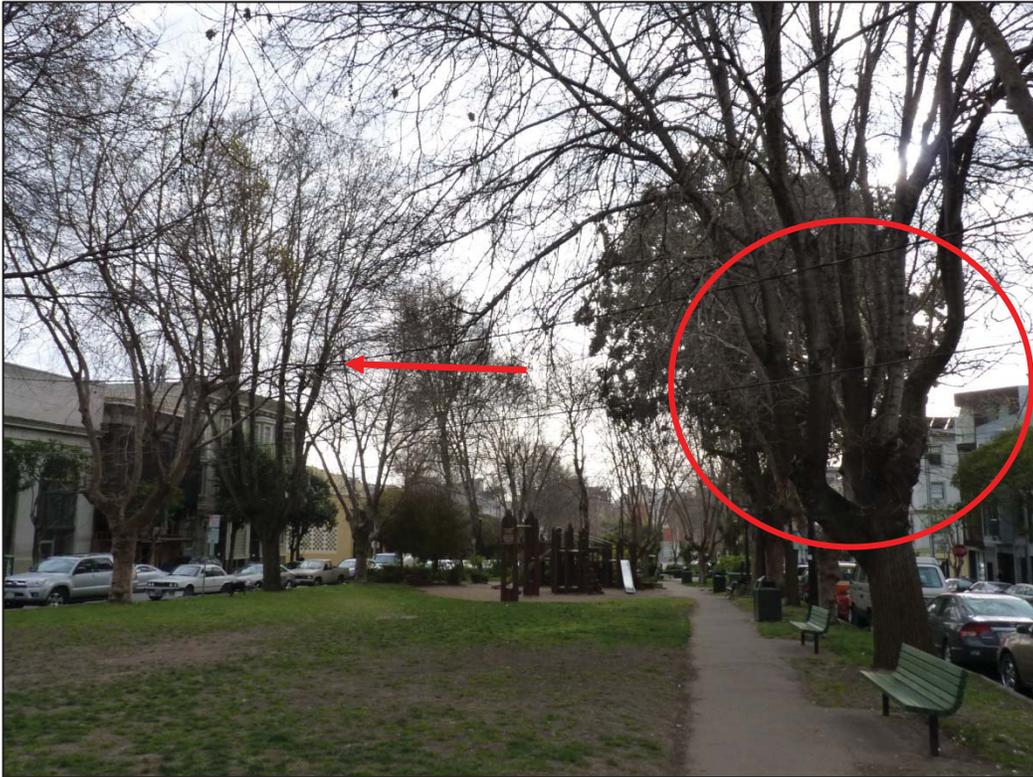
Most London planes had been pollarded when young. As a result, trees have multiple attachments that arise at one point on the trunk, usually between 8’ and 12’. The pollarding treatment was discontinued years ago. Tree crowns are composed of a series of stems that originate at the old pollard (Photo 2).

**Photo 2.** London planes were pollarded when young creating a series of multiple stems low in the crown (circle at right). Once the pollarding was discontinued, stems grew rapidly and now bow outward (red arrow).

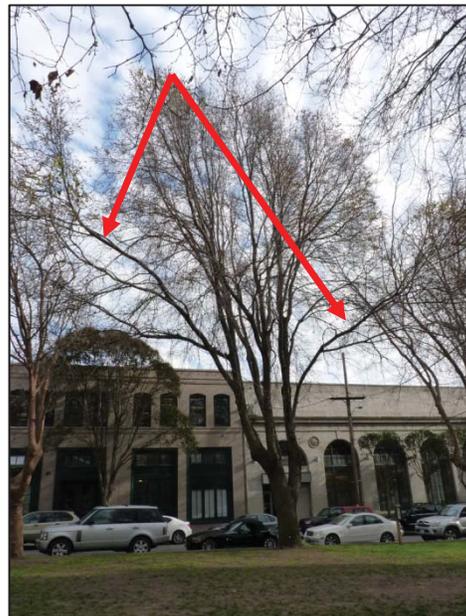
Thirteen (13) American elms were present. All were mature in development with trunk diameters between 16" and 31". Elms had been treated like the London planes and have a similar crown structure. Given the close spacing between trees, elm crowns are narrow and upright in form. Long stems often bow out of the canopy (Photo 3).

**Photo 3.** Stems of American may have had significant bow, to the point where they were separated from the rest of the canopy (red arrows).
