**DRAFT Tree Assessment & Management
Plan
South Park**

Prepared for:
**South Park Improvement Association
C/O Levy Design Partners
90 South Park
San Francisco CA 94107**

Prepared by:
**HortScience, Inc.
325 Ray Street
Pleasanton, CA 94566**

March 2012

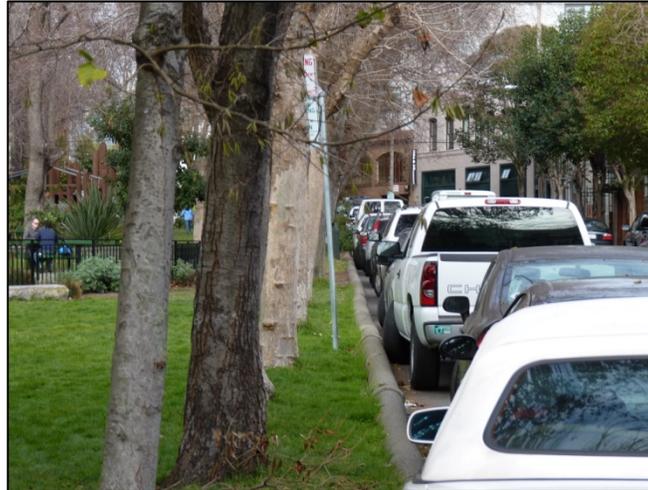
South Park is an elongated oval in form. Almost all trees are planted adjacent to the street within 2’ of the curb (Photo 1). There was, however, little apparent displacement of curb and pavement associated with tree roots. Curbing appeared to be worn due to age and weathering.

Photo 1. Looking east along south side of park. Note that trees are located within a few feet of the street. But there is little displacement of the curb.

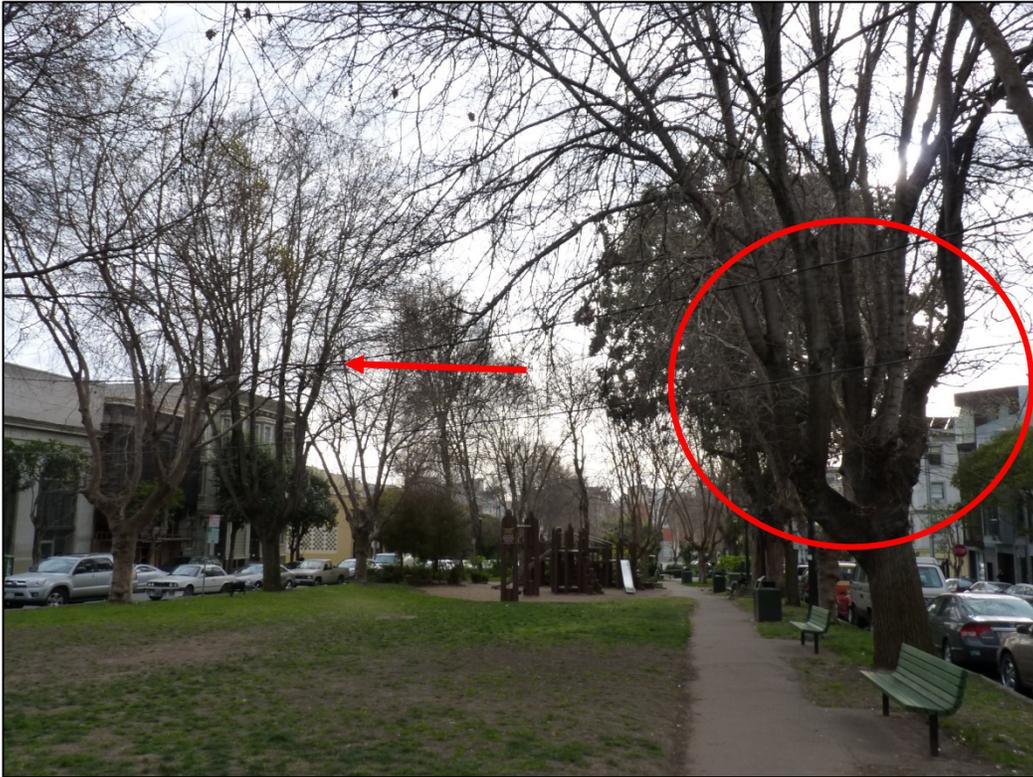
Most London planes had been pollarded when young. As a result, trees have multiple attachments that arise at one point on the trunk, usually between 8’ and 12’. The pollarding treatment was discontinued years ago. Tree crowns are composed of a series of stems that originate at the old pollard (Photo 2).

Photo 2. London planes were pollarded when young creating a series of multiple stems low in the crown (circle at right). Once the pollarding was discontinued, stems grew rapidly and now bow outward (red arrow).

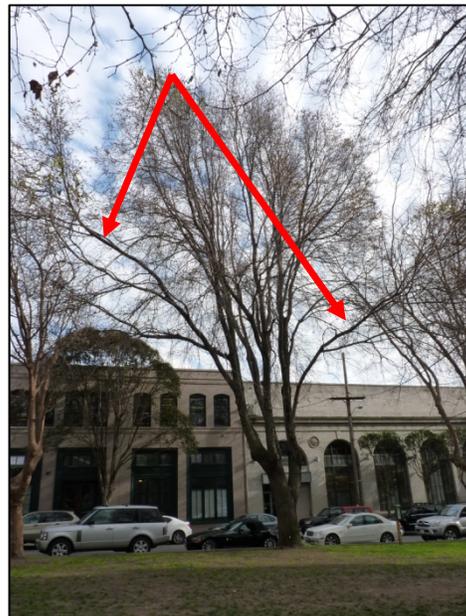
Thirteen (13) American elms were present. All were mature in development with trunk diameters between 16" and 31". Elms had been treated like the London planes and have a similar crown structure. Given the close spacing between trees, elm crowns are narrow and upright in form. Long stems often bow out of the canopy (Photo 3).

Photo 3. Stems of American may have had significant bow, to the point where they were separated from the rest of the canopy (red arrows).
