# **BUENA VISTA PARK**

## **Needs Assessment and Cost Analysis**

**COMMUNITY MEETING #2**

Primary Consultant:  
**Miller Company Landscape Architects**

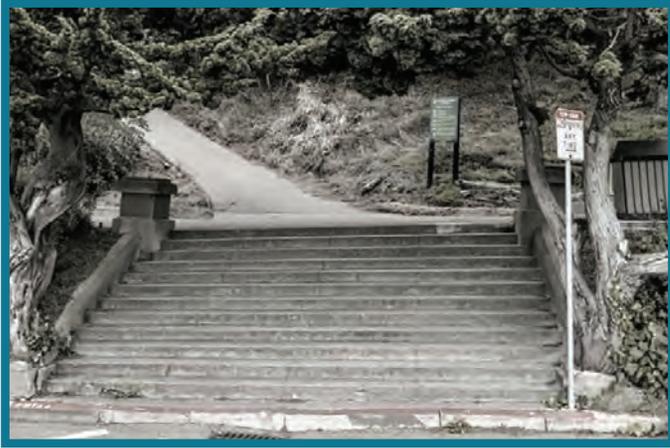
BEFORE - HISTORIC STAIR REPLACEMENT

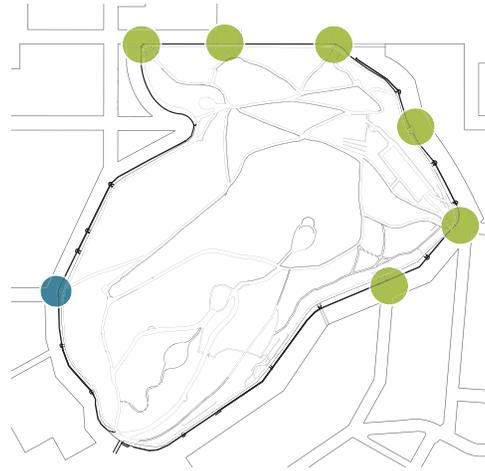
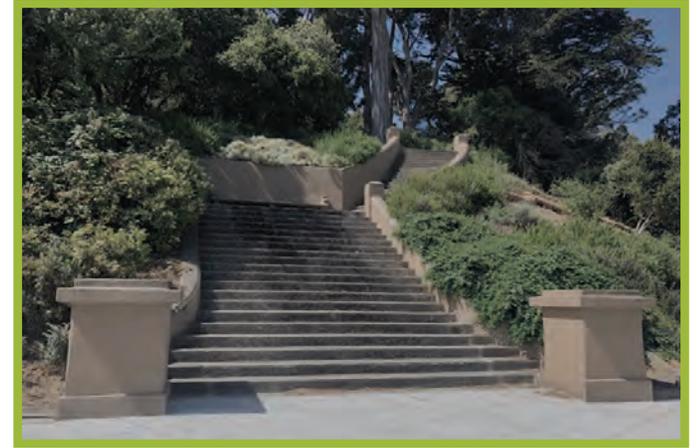
BEFORE - HISTORIC STAIR REPAIR

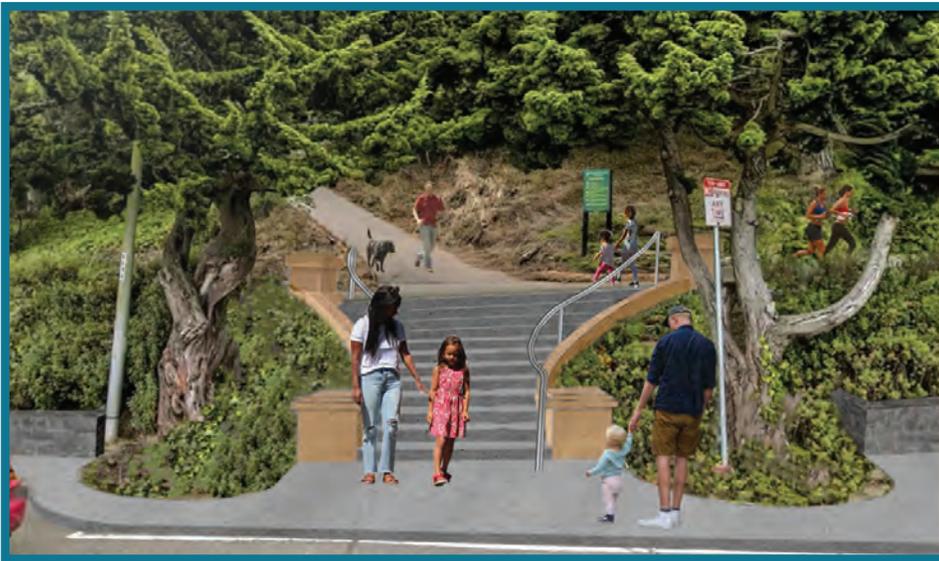
AFTER - HISTORIC STAIR REPLACEMENT

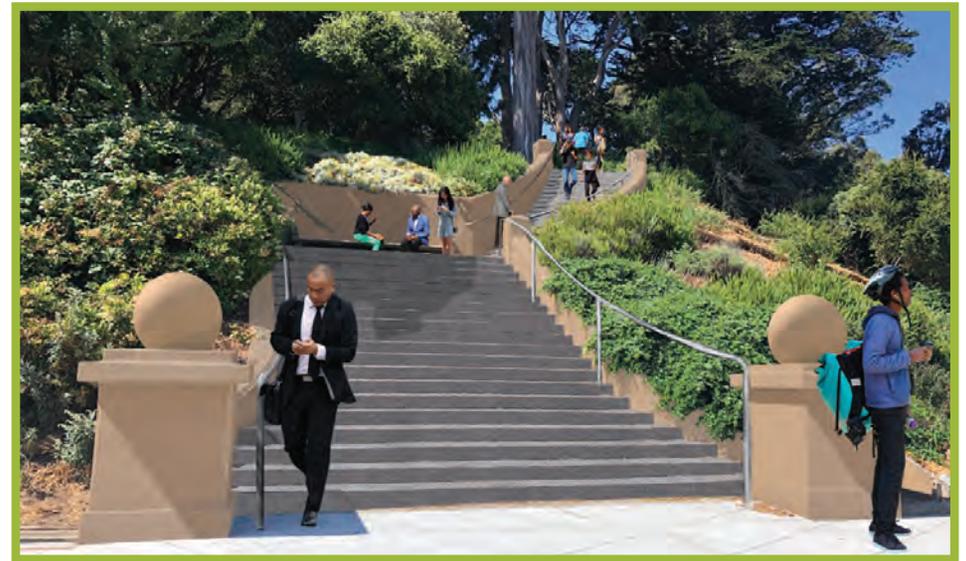
AFTER - HISTORIC STAIR REPAIR

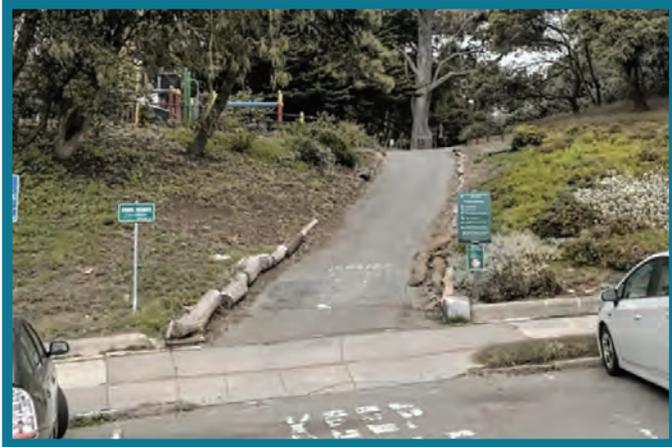
BEFORE - WALLER ENTRY

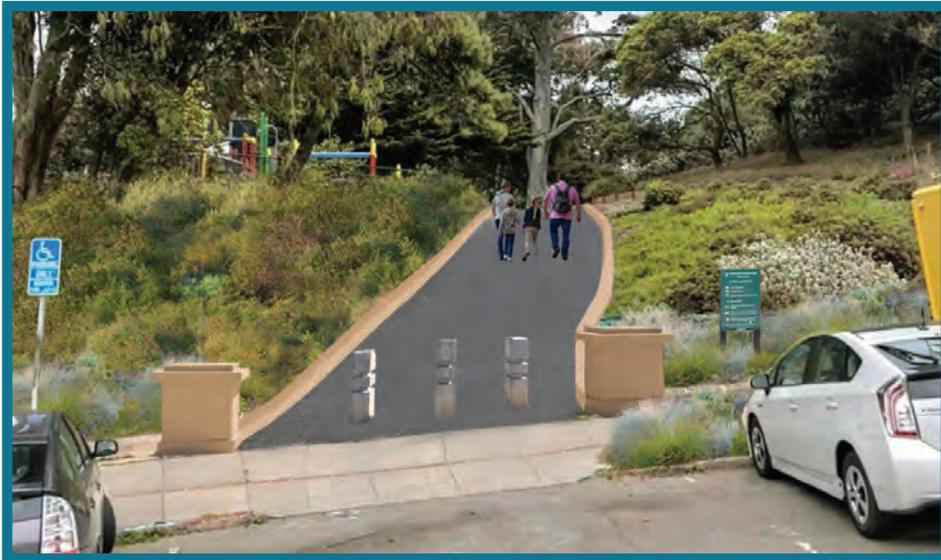
AFTER - WALLER ENTRY

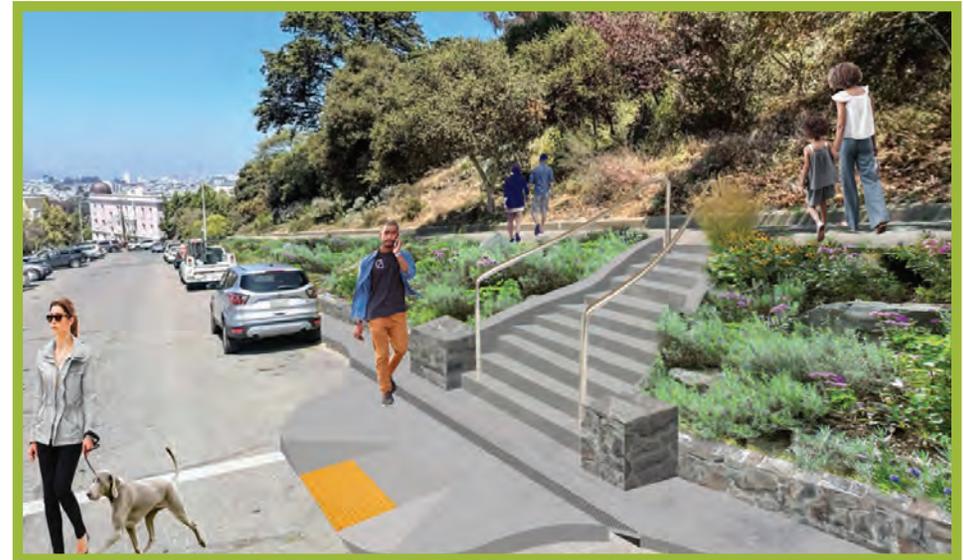
AFTER - PERIMETER STAIRS

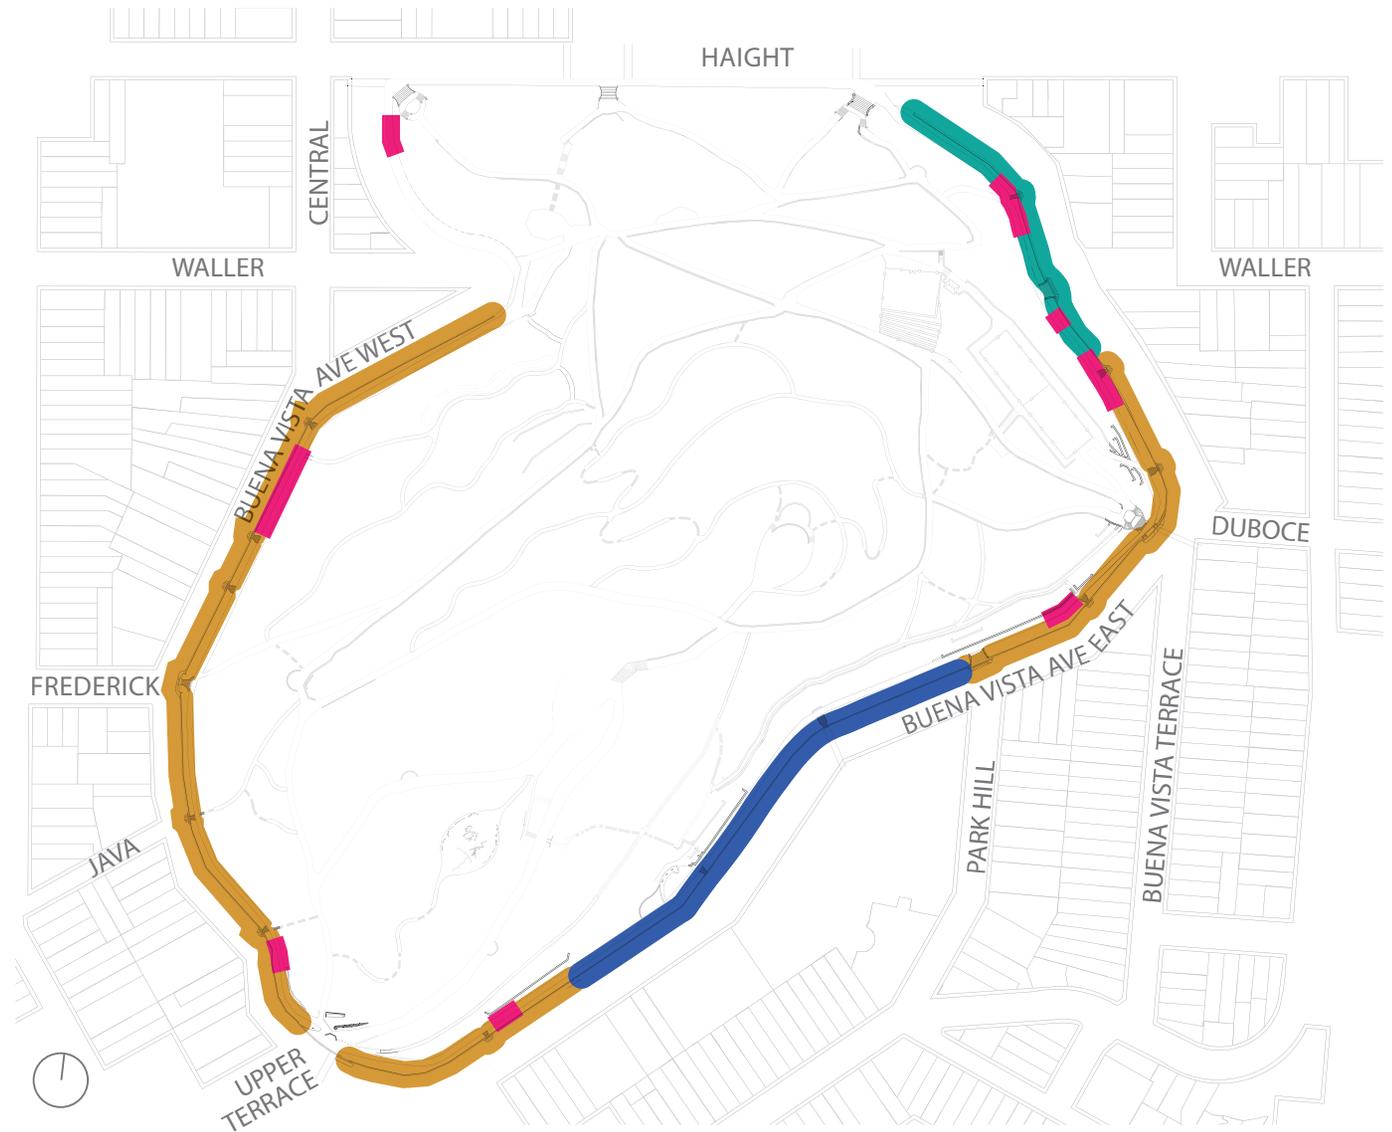
# PERIMETER HARDSCAPE IMPROVEMENT MAP

- PERIMETER WALK IMPROVEMENT
- PARALLEL PARKING CURBSIDE IMPROVEMENT
- 90 DEGREE PARKING CURBSIDE IMPROVEMENT
- NO PARKING EDGE IMPROVEMENT

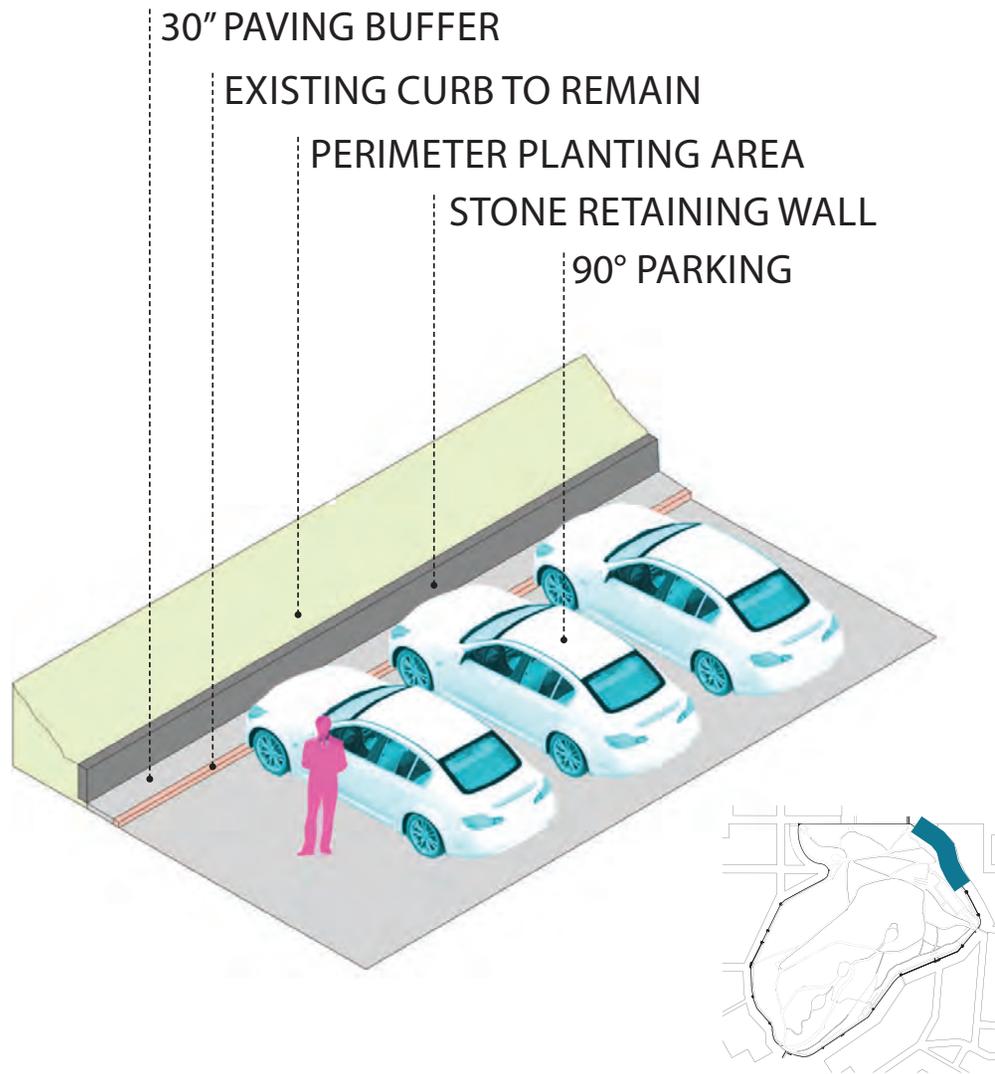
## 90 DEGREE PARKING CURBSIDE IMPROVEMENT

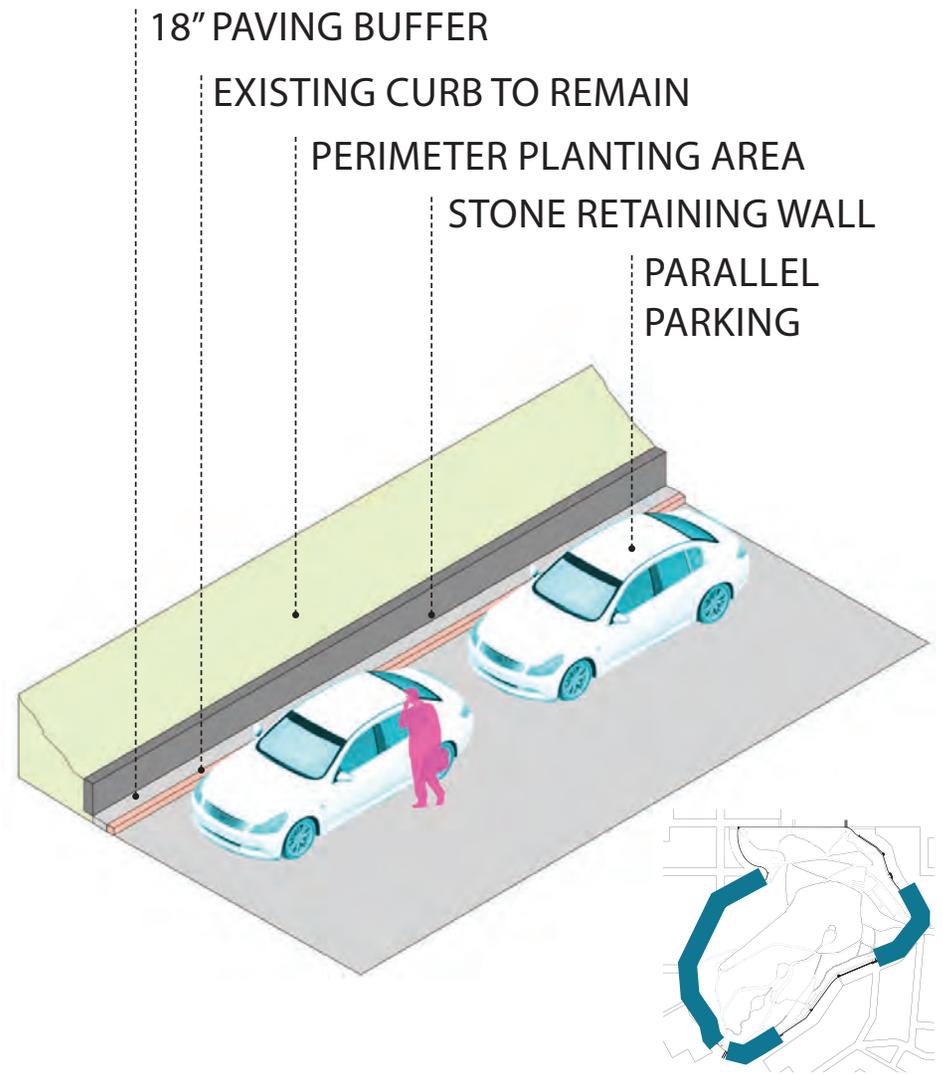
## PARALLEL PARKING CURBSIDE IMPROVEMENT

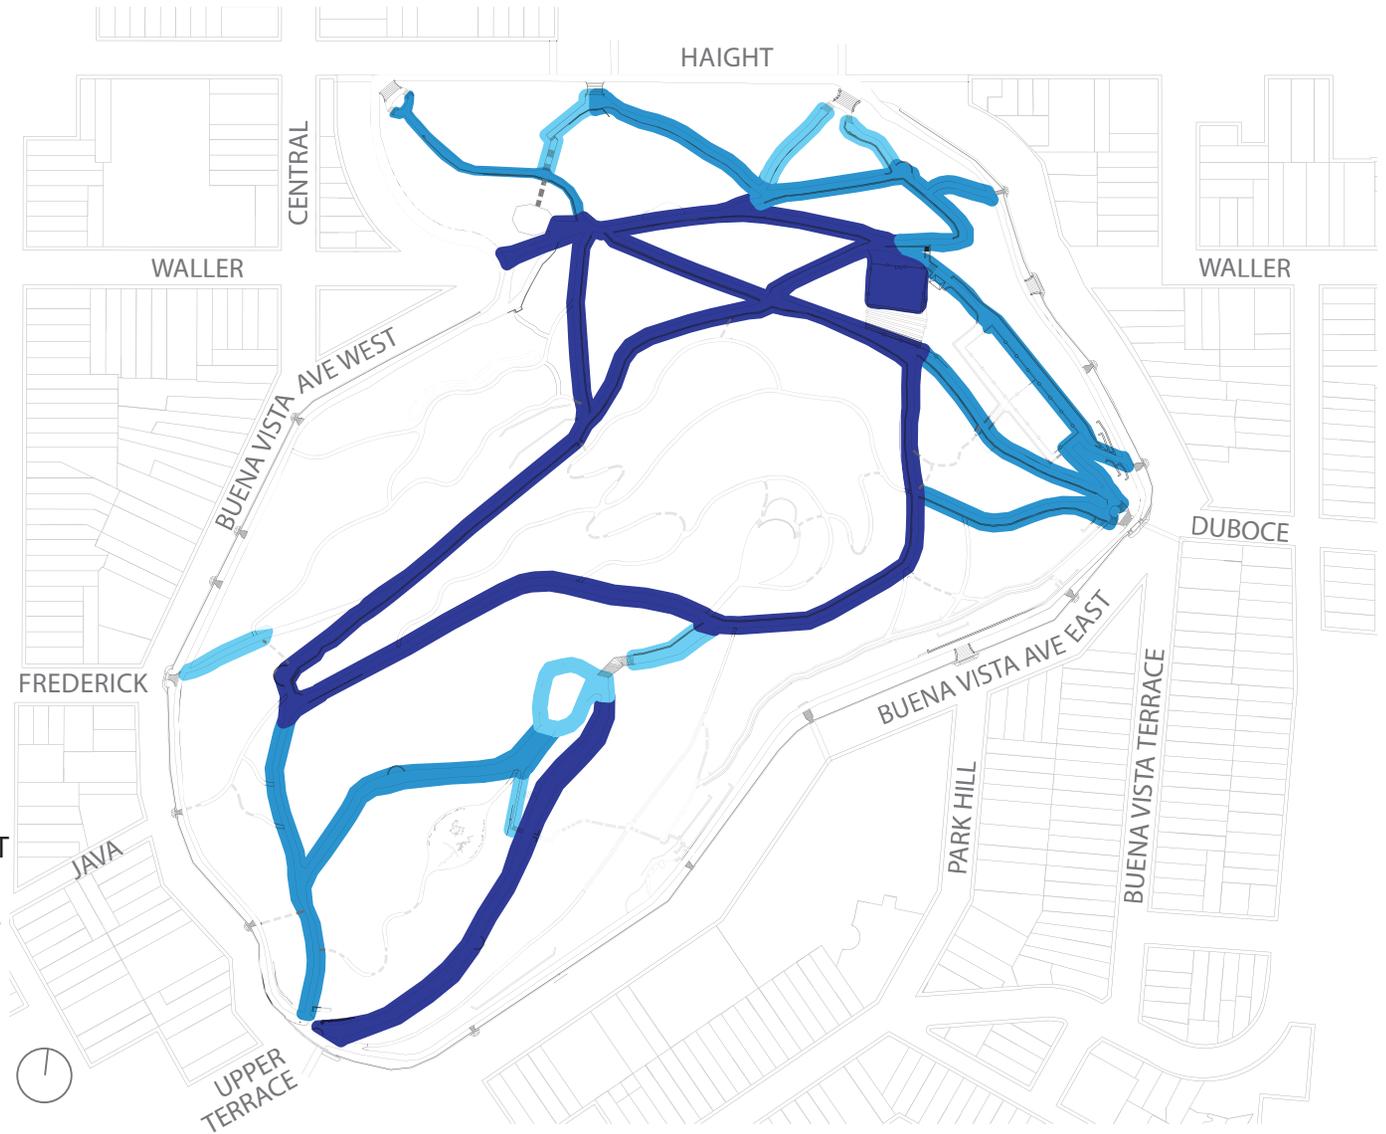
# ASPHALT IMPROVEMENT MAP

HEAVY VEHICLE ASPHALT REPLACEMENT
-

LIGHT VEHICLE ASPHALT REPLACEMENT
-

PEDESTRIAN ASPHALT REPLACEMENT

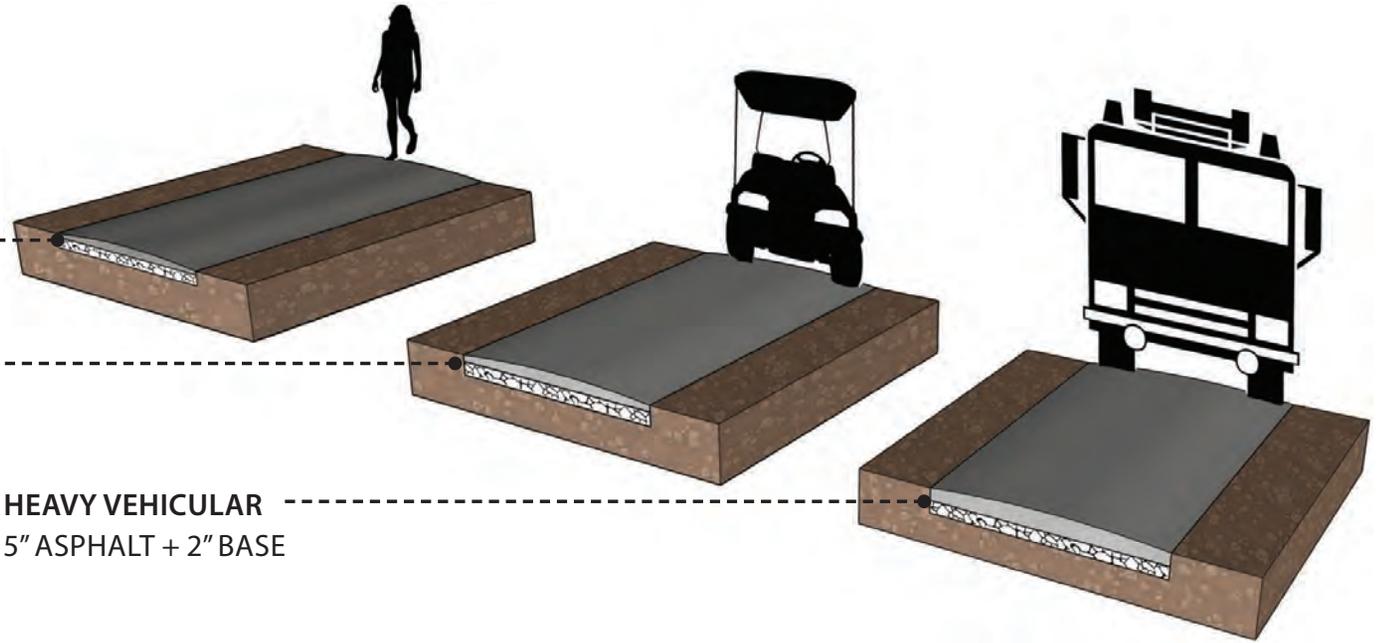
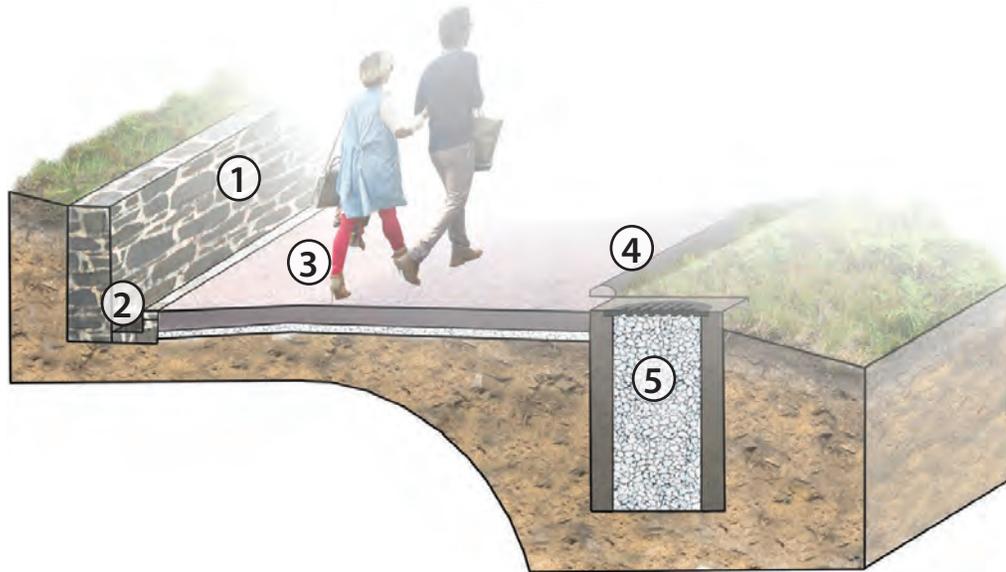
PEDESTRIAN: ---  
3" ASPHALT + 2" BASE

LIGHT VEHICULAR ---  
4.5" ASPHALT + 2" BASE

HEAVY VEHICULAR ---  
5" ASPHALT + 2" BASE

- ① EXISTING STONE WALL
- ② HISTORIC DRAINAGE GUTTER WITH EXTENDED STONE CURB
- ③ CROWNED ASPHALT PAVING
- ④ ASPHALT DIKE
- ⑤ DRY WELL

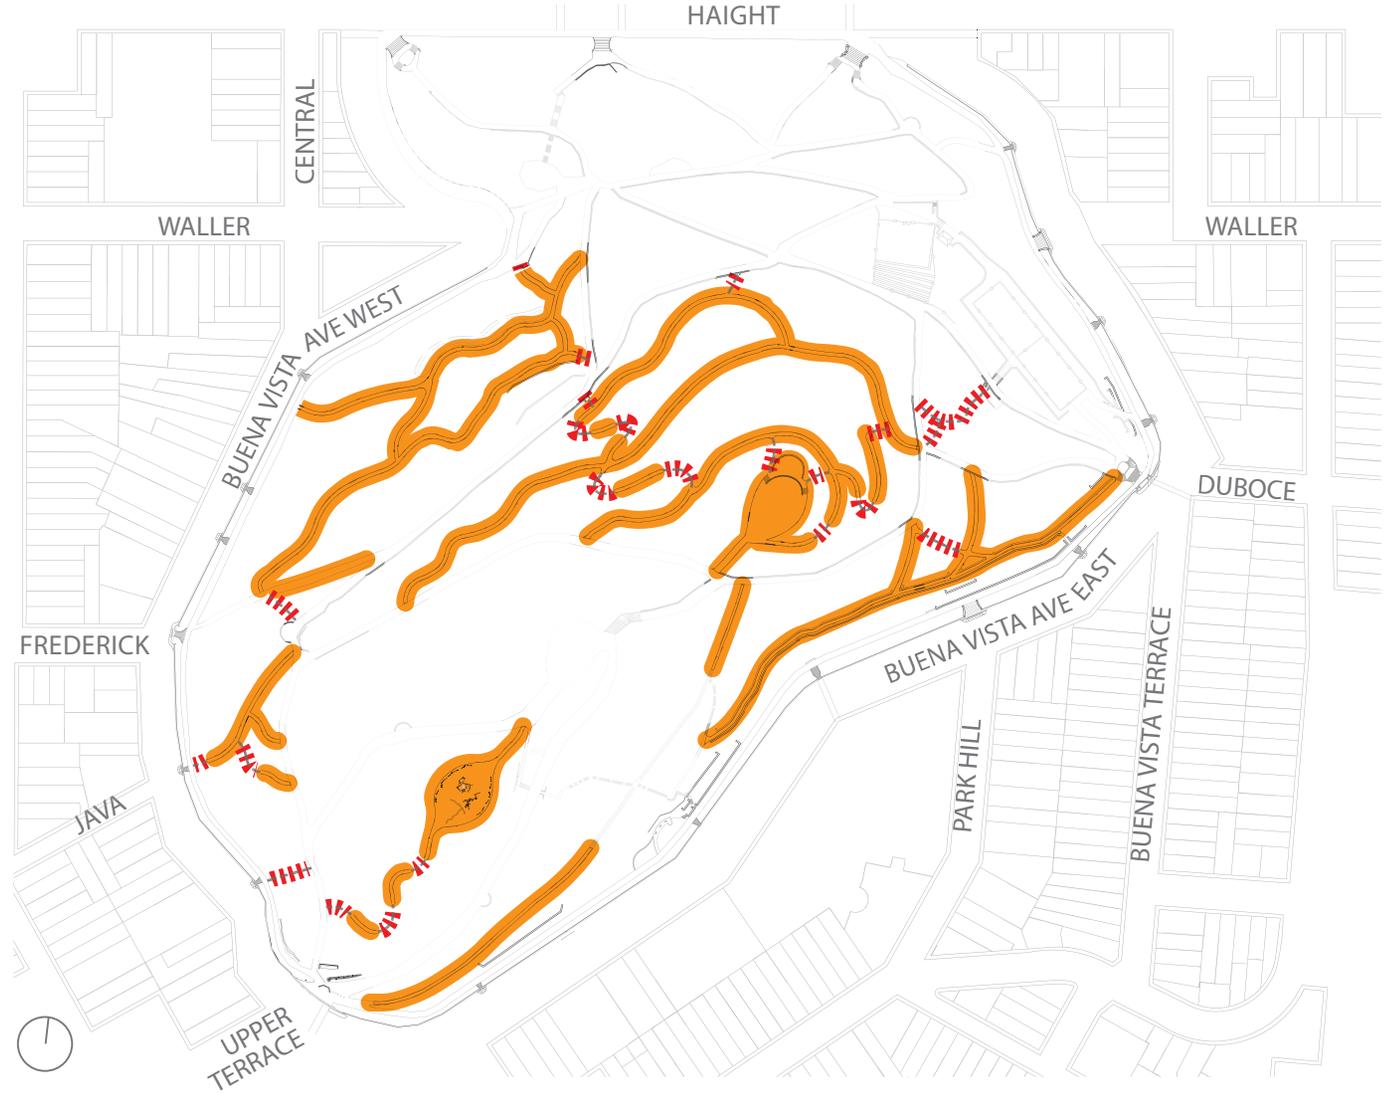
# RUSTIC TRAIL SYSTEM IMPROVEMENT MAP

RUSTIC STAIRS
-

RUSTIC TRAILS

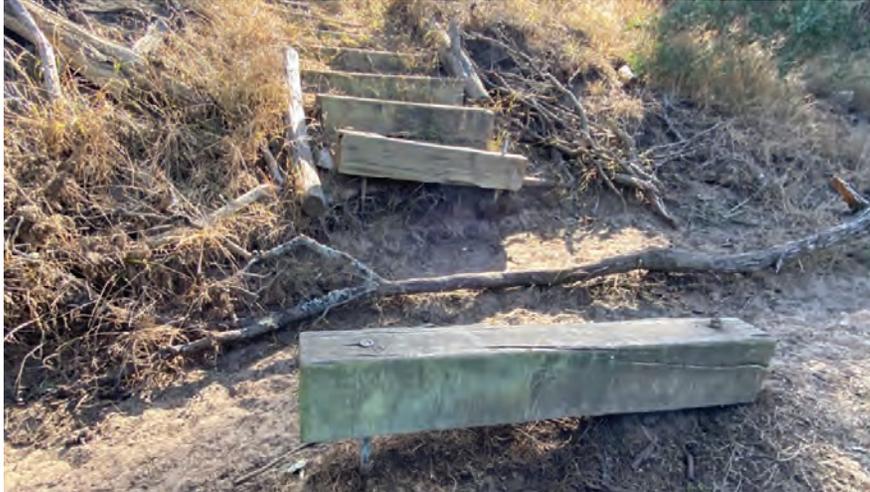
EXISTING WOOD STAIRS

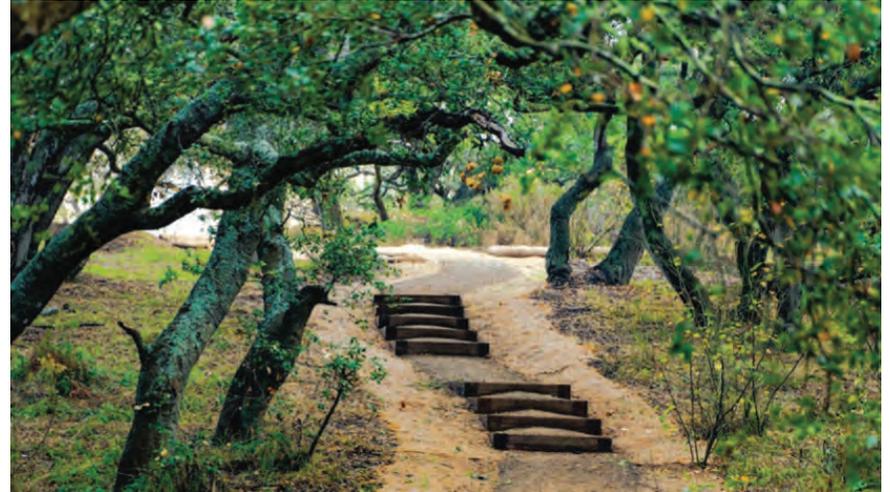
BOX STAIRS AT OAK WOODLANDS

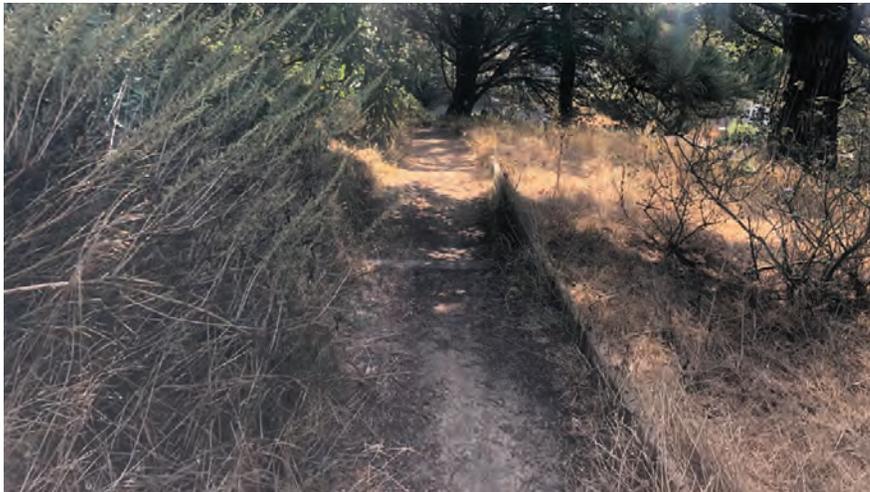
EXISTING PATHWAYS

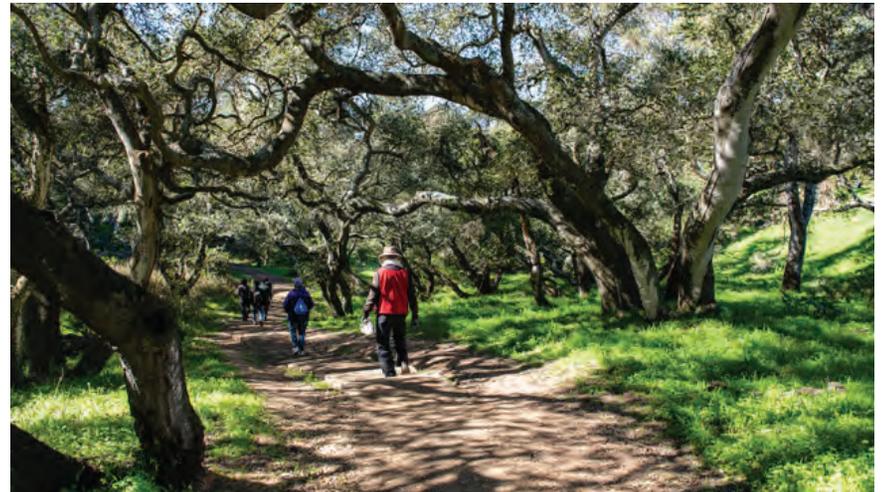
PARK TREAD PATHWAYS AT OAK WOODLANDS

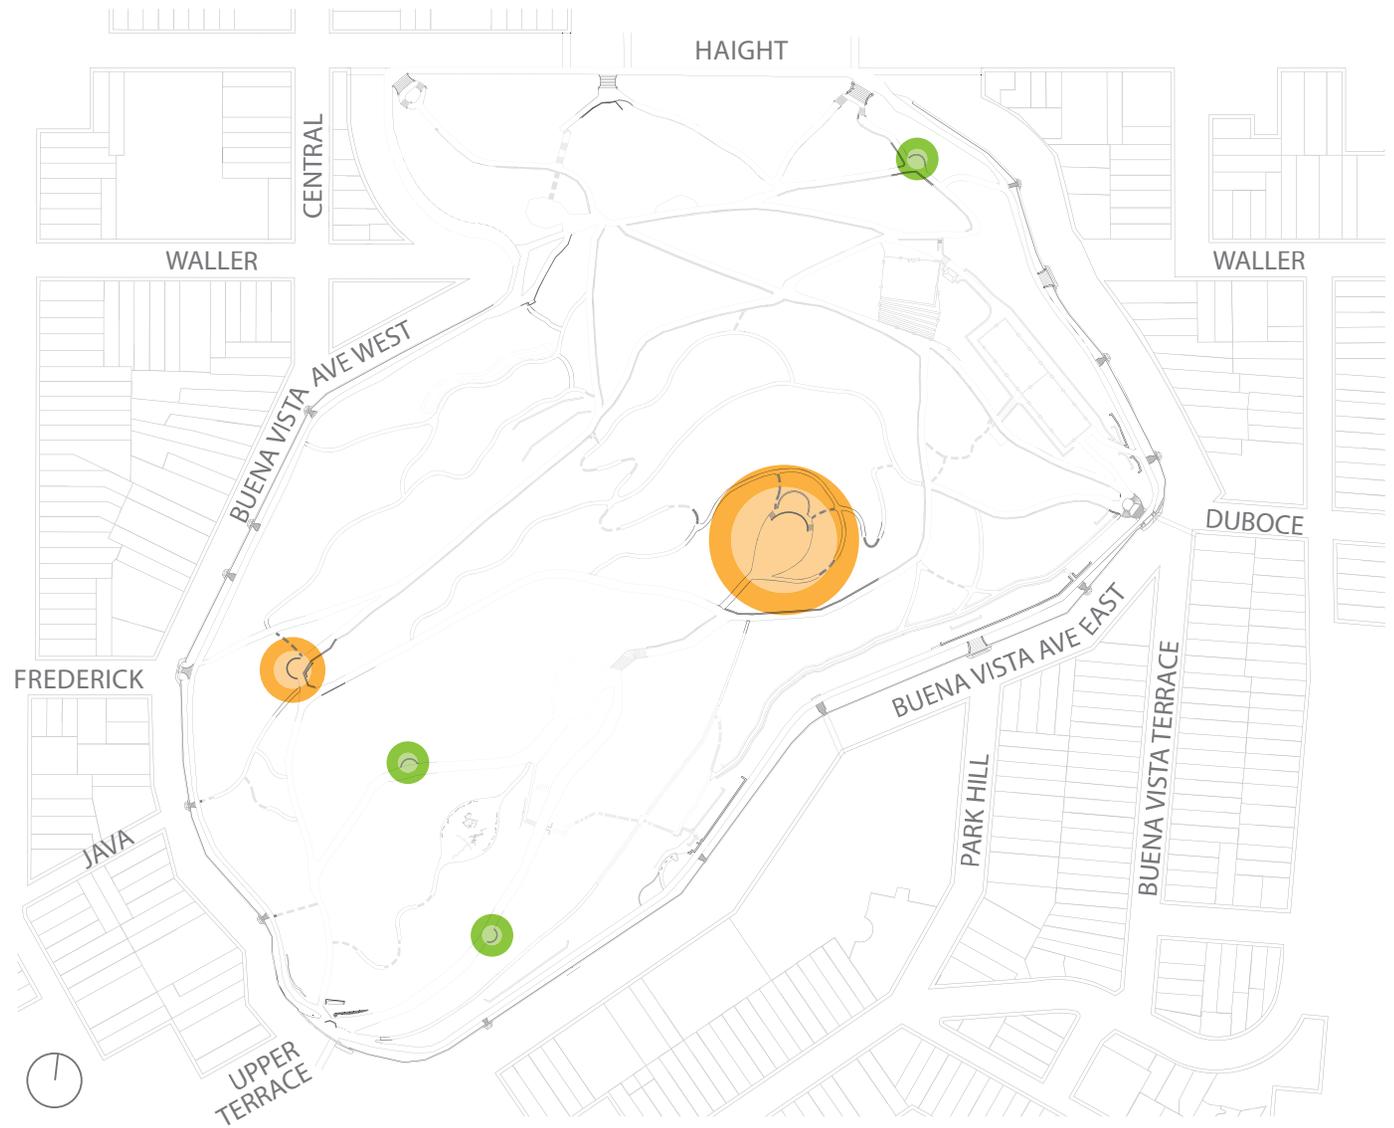
# OVERLOOKS IMPROVEMENT MAP

REDESIGNED OVERLOOKS
-

PROPOSED OVERLOOKS

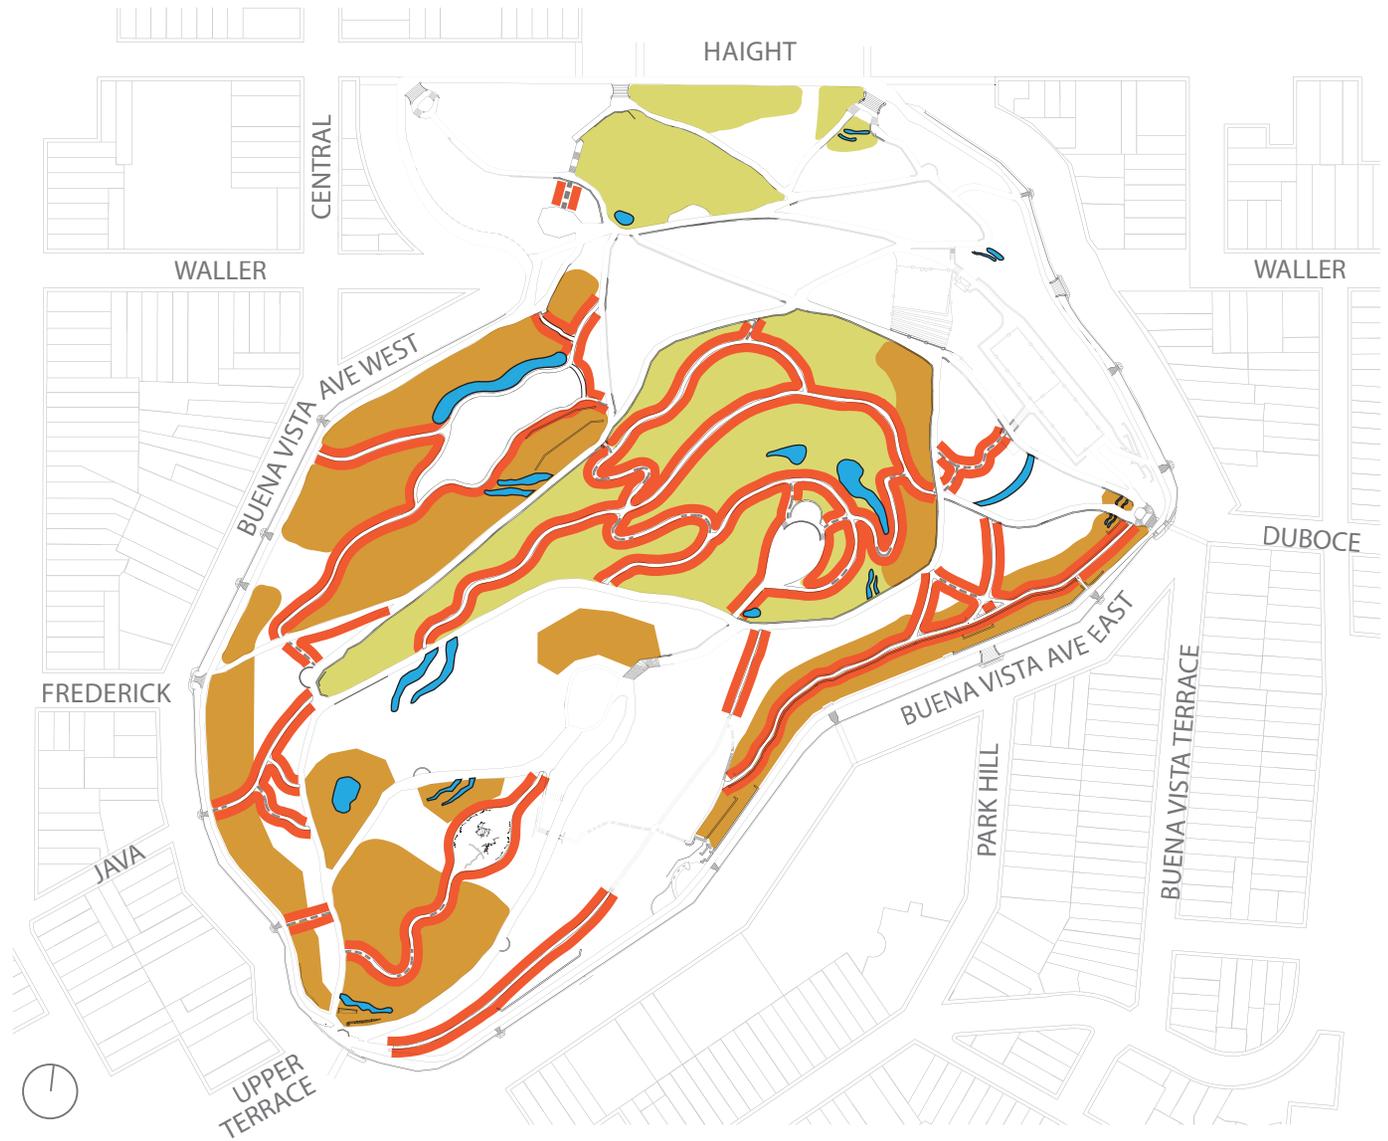
# EROSION CONTROL IMPROVEMENT MAP

EROSION CONTROL BLANKET & COIR AT RUSTIC PATHWAYS AND STAIRS
-

EROSION CONTROL BLANKET & COIR
-

EROSION CONTROL BLANKET
-

STORMWATER FEATURE

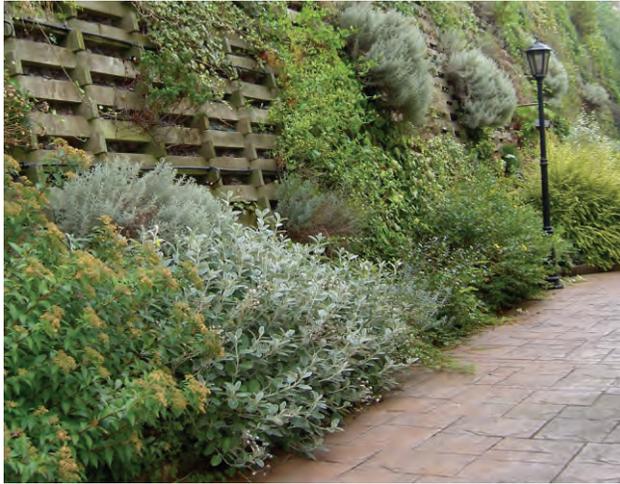
GRAVITY BLOCK WALL

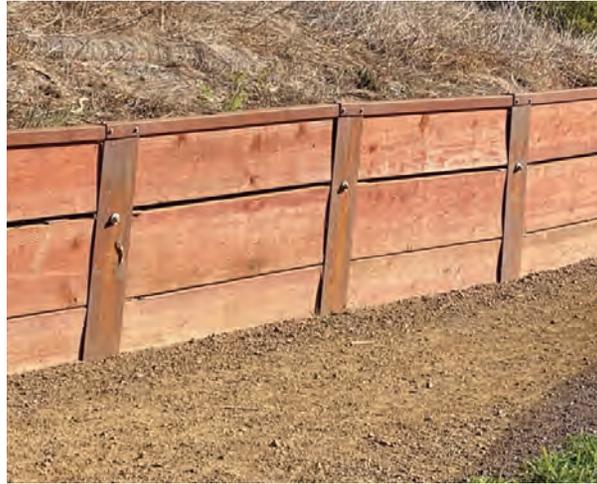
SUTTER WALL

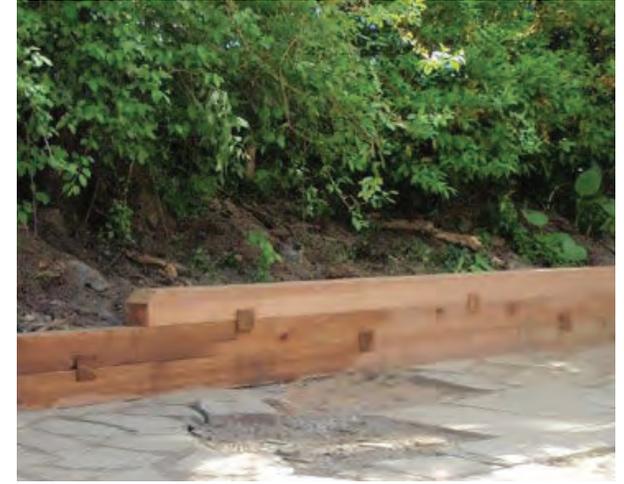
TIMBER WALL

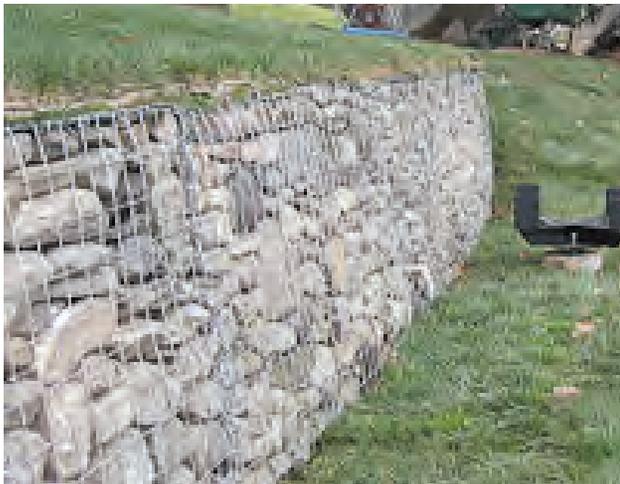
GABION WALL

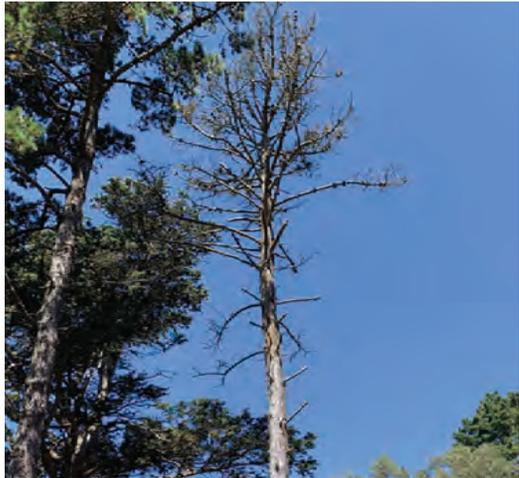
**DECAYING PINE TREE**

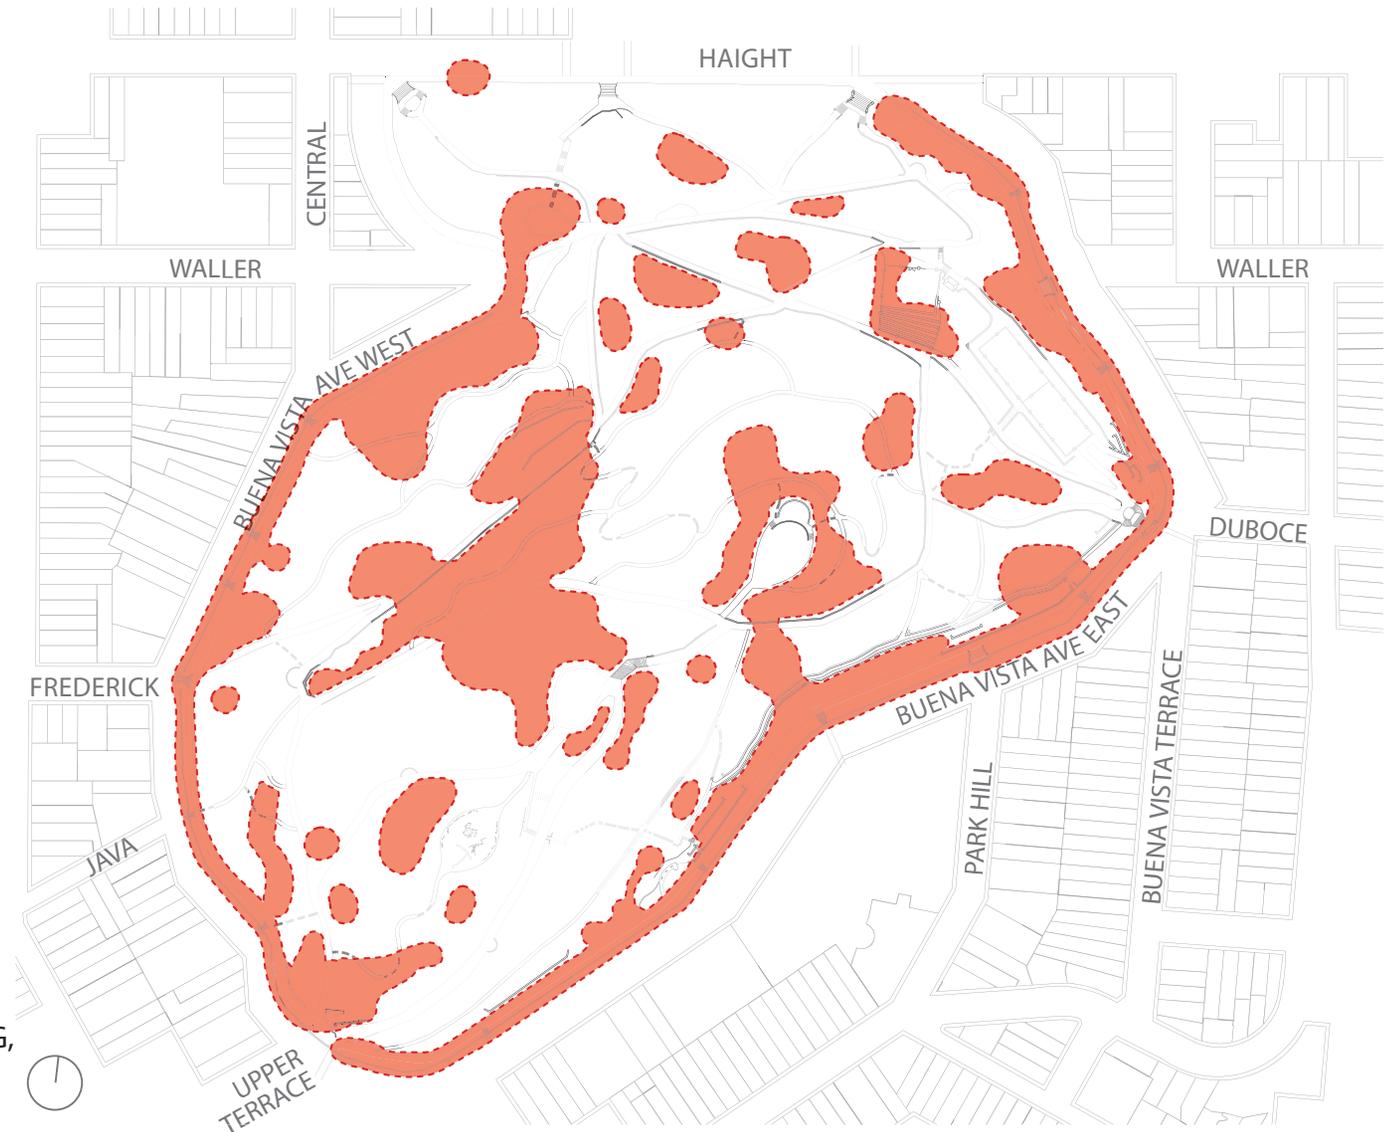
# FOREST & PLANTING REMOVAL MAP

SELECTIVE TREE REMOVAL & PRUNING,  
INVASIVE SPECIES REMOVAL

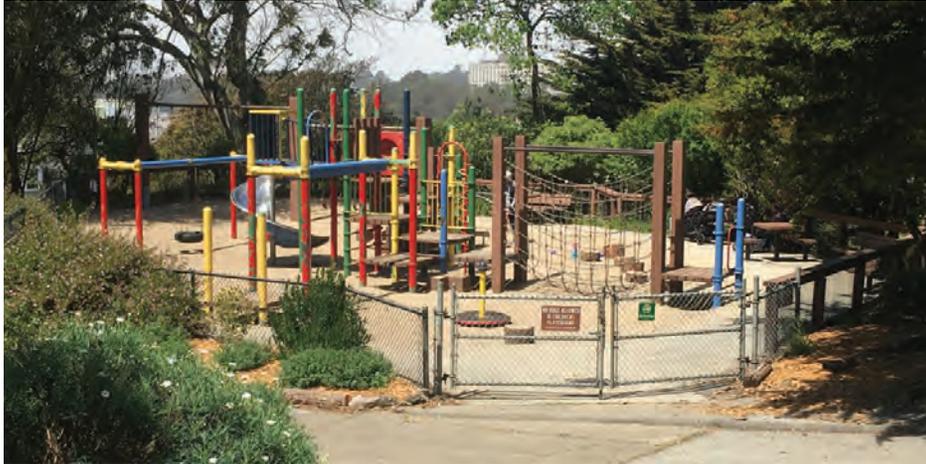
OUTDATED EXISTING PLAYGROUND

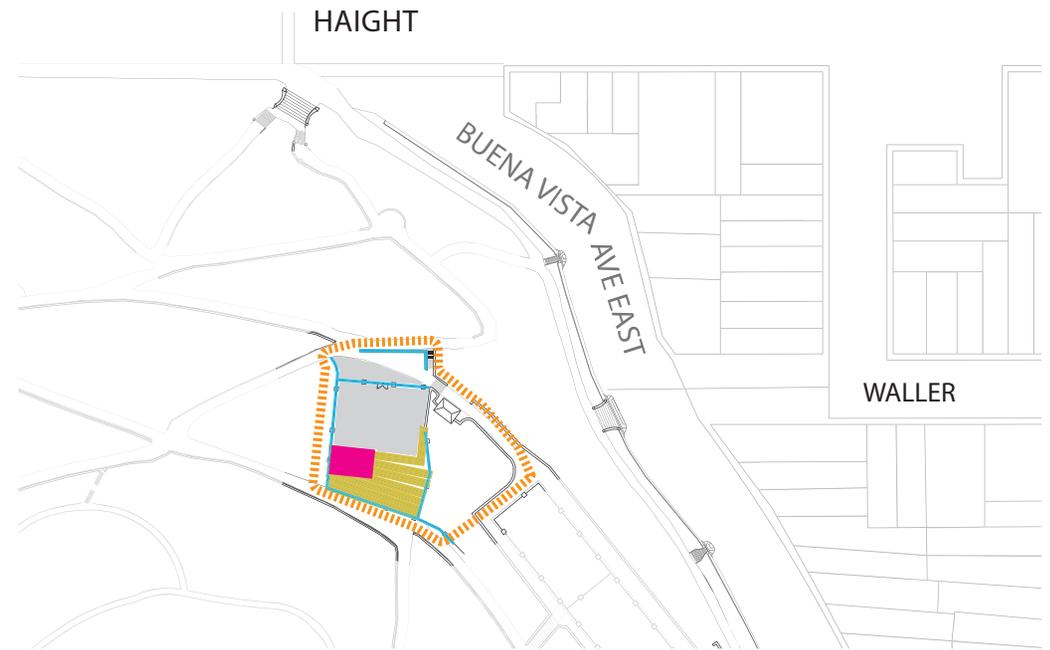
- MAINTENANCE BUILDING

- GRAVITY BLOCK WALL

- YARD FENCING

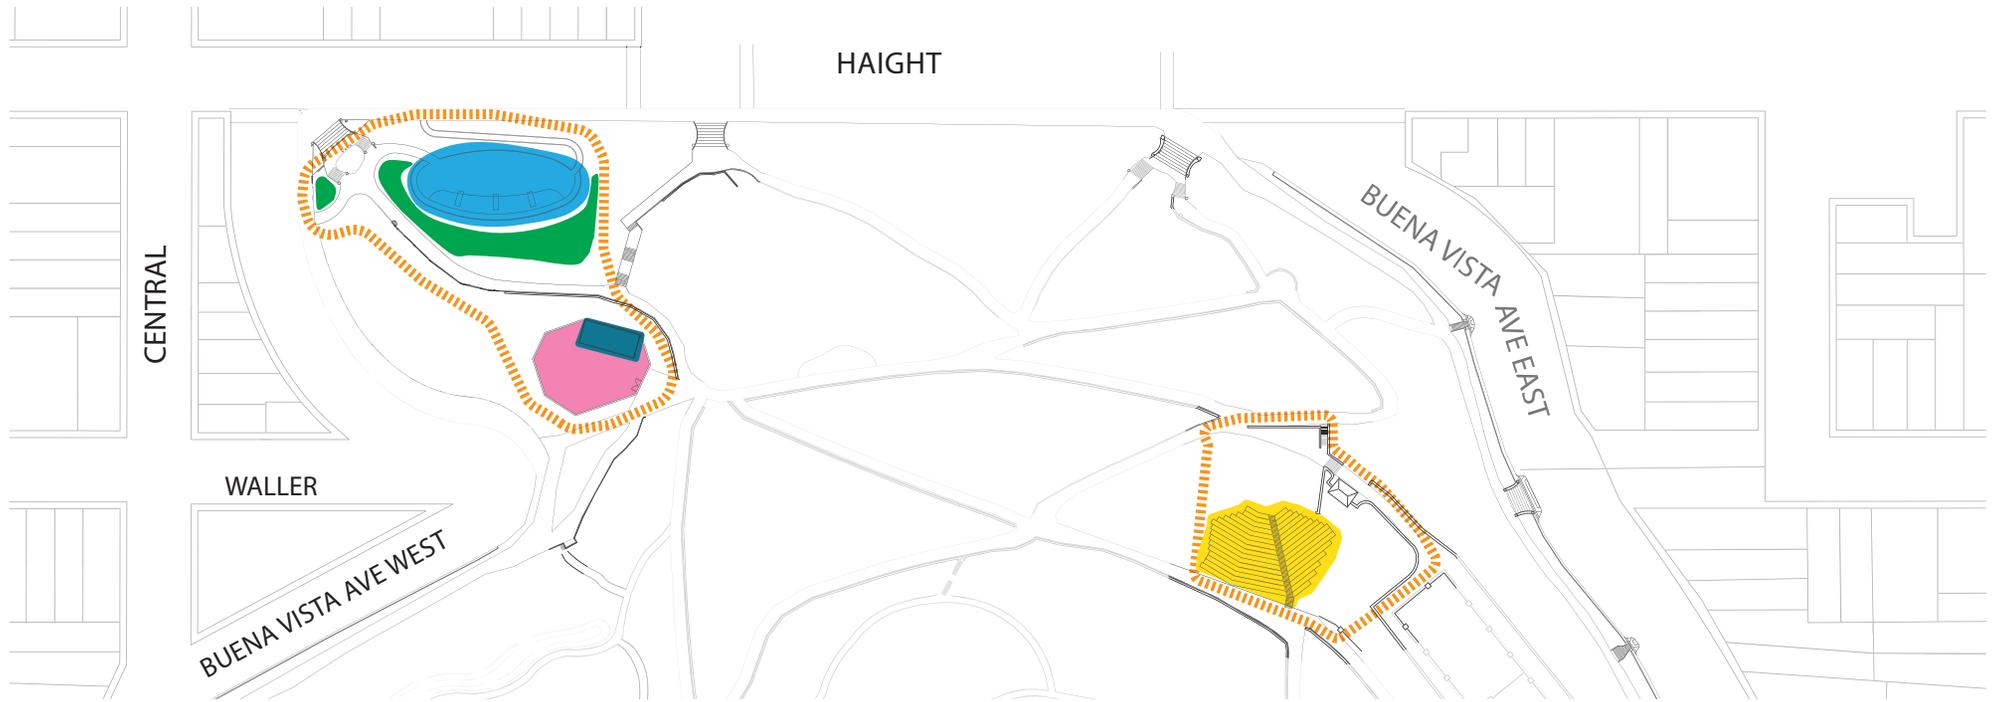
# 5 AMPHITHEATER, RELOCATED MAINTENANCE AREA AND PLAYGROUND

MAINTENANCE YARD

MAINTENANCE BUILDING

AMPHITHEATER

PLAYGROUND

<b>ADDITIONAL DESIGN OPPORTUNITIES (INCLUDES HARD AND SOFT COST)</b>	
<b>DESIGN 1:</b> PERIMETER WALKWAY COMPLETE REPLACEMENT	\$5,300,000
<b>DESIGN 2:</b> PLAYGROUND RELOCATION + PICNIC AREA	\$3,000,000
<b>DESIGN 3:</b> SOUTH SUMMIT GLADE UPGRADE (RUSTIC TRAIL SYSTEM, EROSION CONTROL, PLANTING + FITNESS EQUIPMENT)	\$5,800,000
<b>DESIGN 4:</b> NEW MAINTENANCE FACILITY BUILDING	\$910,000
<b>DESIGN 5:</b> AMPHITHEATER, RELOCATED MAINTENANCE FACILITY + RELOCATED PLAY AREA	\$7,800,000
