**Date:** June 2, 2017

**Re:** Golden Gate Park – Beach Chalet Athletic Field Lighting Evaluation

**Project/Site Information:**

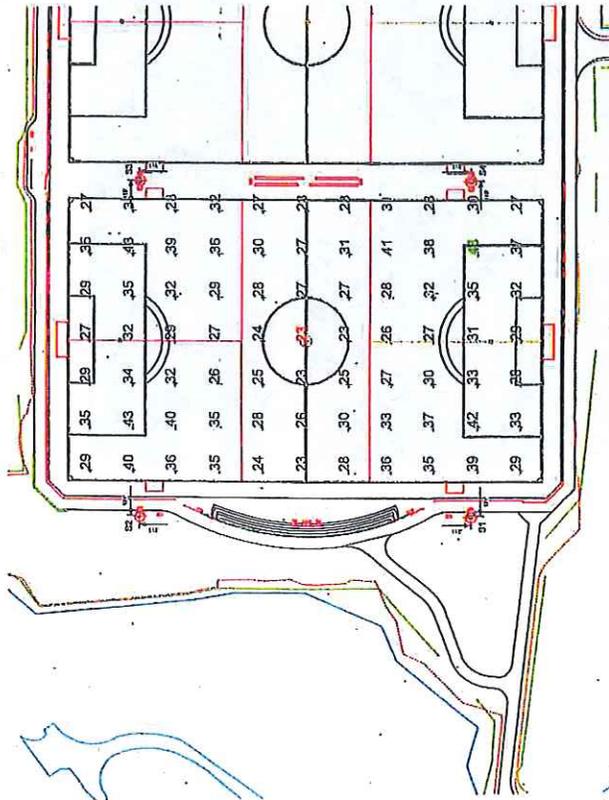
Project Name: Beach Chalet Soccer  
 Project Number: 139305  
 Field Identification: Soccer 1

Pre Readings  
 Average: 31  
 Max: 43  
 Min: 23

Post Readings  
 Average: 31.3  
 Max: 44  
 Min: 23

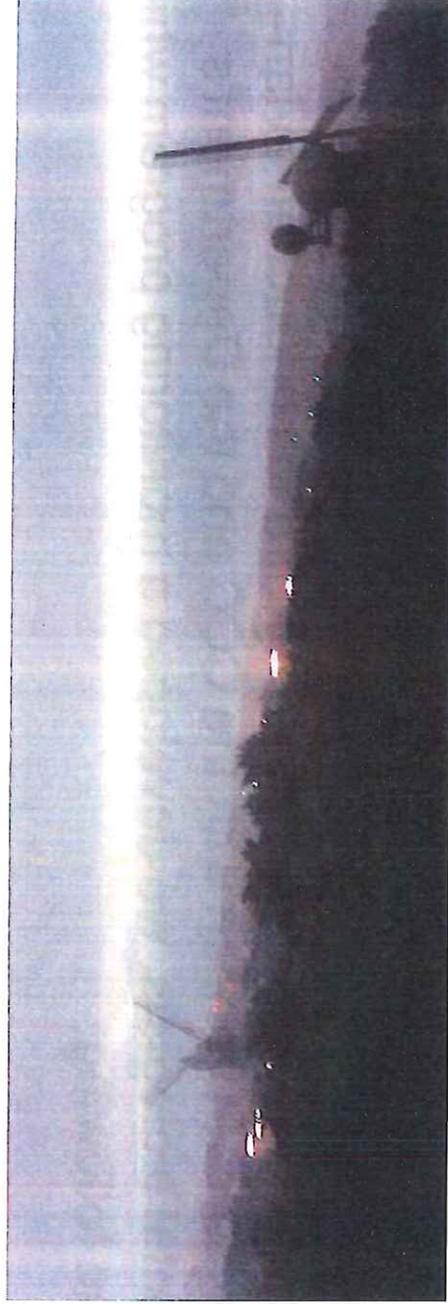
Photo from neighbor that lives on Sutro Heights

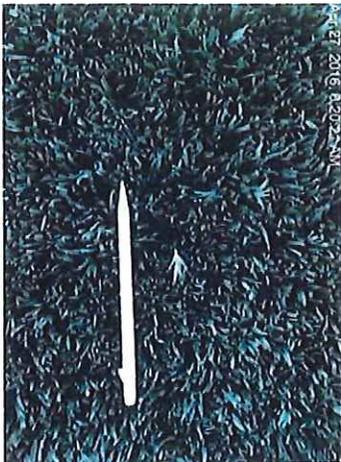
The majority of the feathers were small and downy (Photo 1). Only two larger feathers (wing or portion of a tail feather) were collected (Photo 2). Most feathers were observed within 50 feet of light poles. No sign of blood or other avian body parts were observed in association with the feathers. It is possible that the many ravens which reside in the vicinity of the athletic fields routinely preen atop the light stands and shed these feathers.

Photo 1: Downy feather sample.

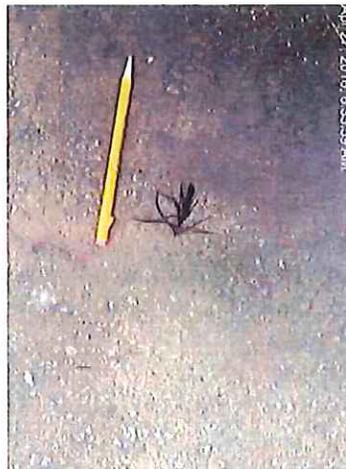
Photo 2: Wing or tail feather sample.

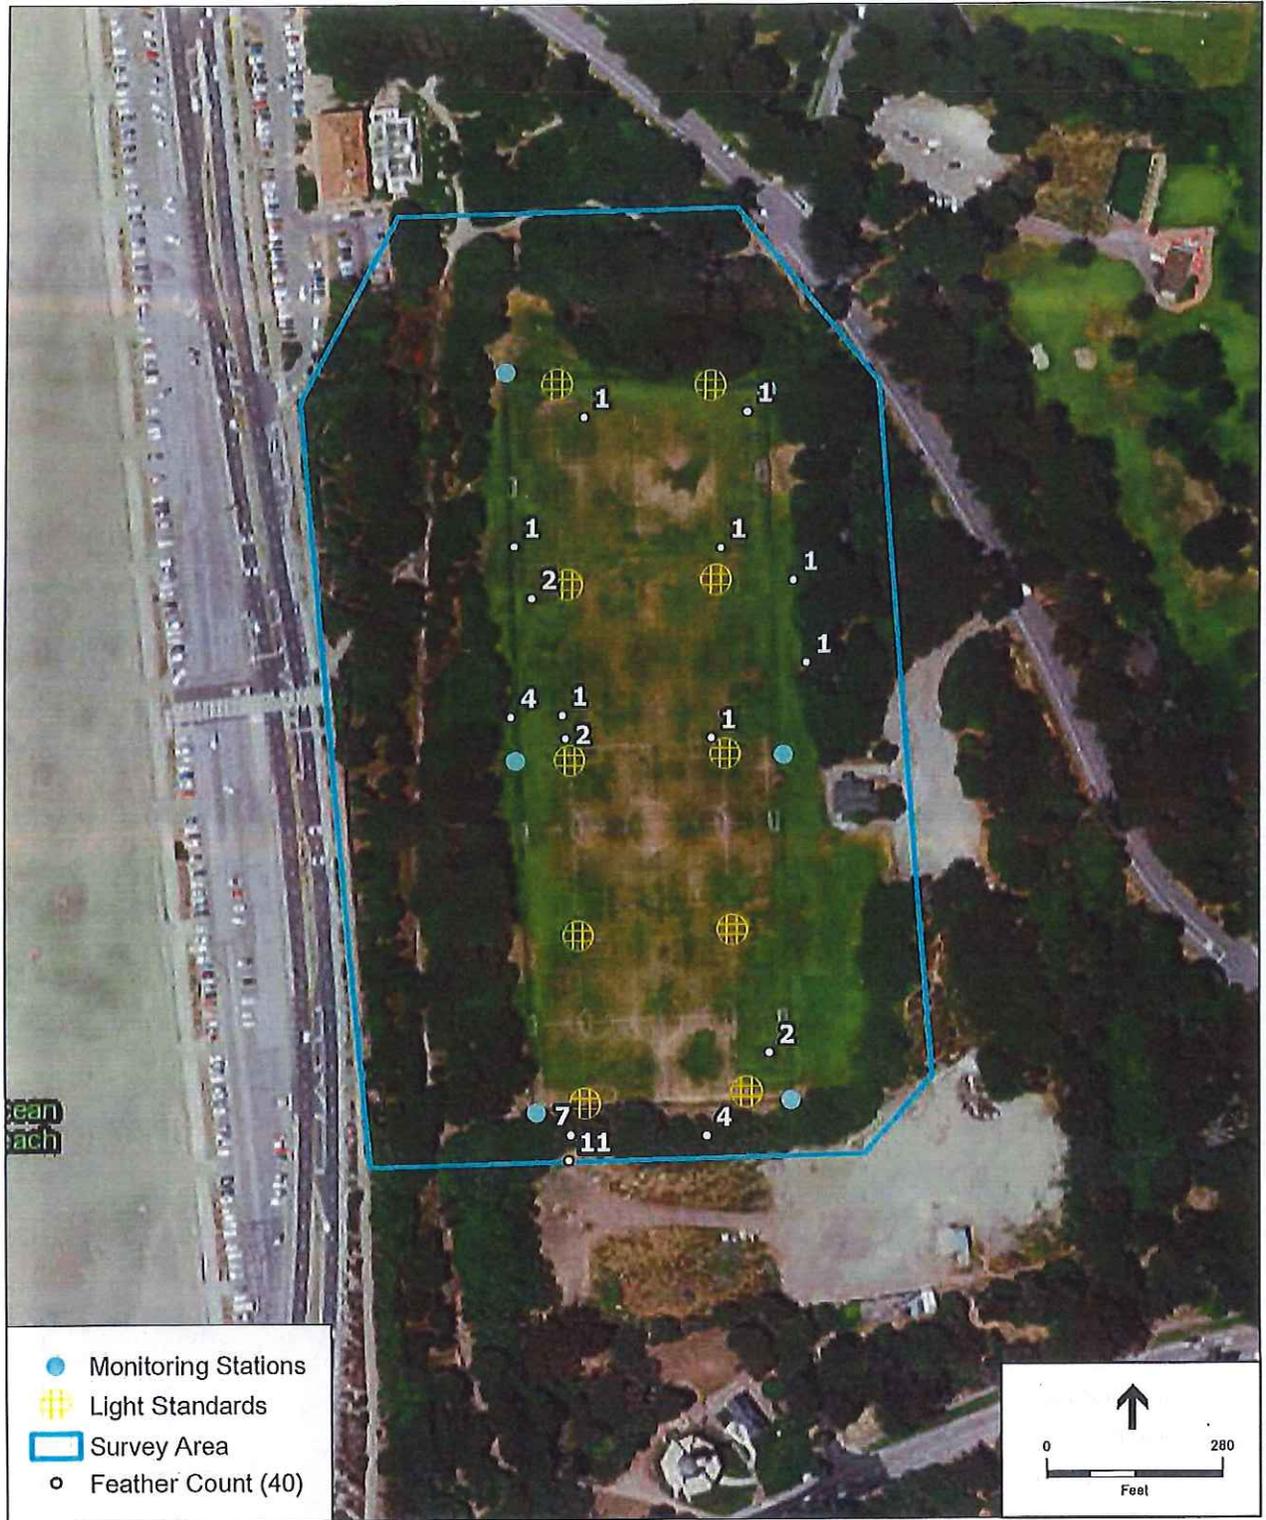
**Figure 1**

A total of 105 feathers were observed on the athletic fields during the morning sweep. Each feather was photographed in context of the nearest light pole and up close with groups of feathers documented together. GPS data was also taken and the feather was collected. **Figure 2** depicts the location of feathers or groups of feathers collected during the survey.

The majority of the feathers were small and downy though some larger feathers were also observed and collected. Feathers were documented between 15 and 90 feet of light poles with the majority within 50 feet. No sign of blood or other avian body parts were observed in association with the feathers. It is likely these feathers are the result of birds preening in the vicinity of the fields in trees or atop the light poles. The fields within pitches used the previous night contained fewer feathers than unused fields, which may indicate feathers dropped to the field during the day or throughout the week between monitoring events are disturbed by play on the fields.

4.27.2016 Feather Locations

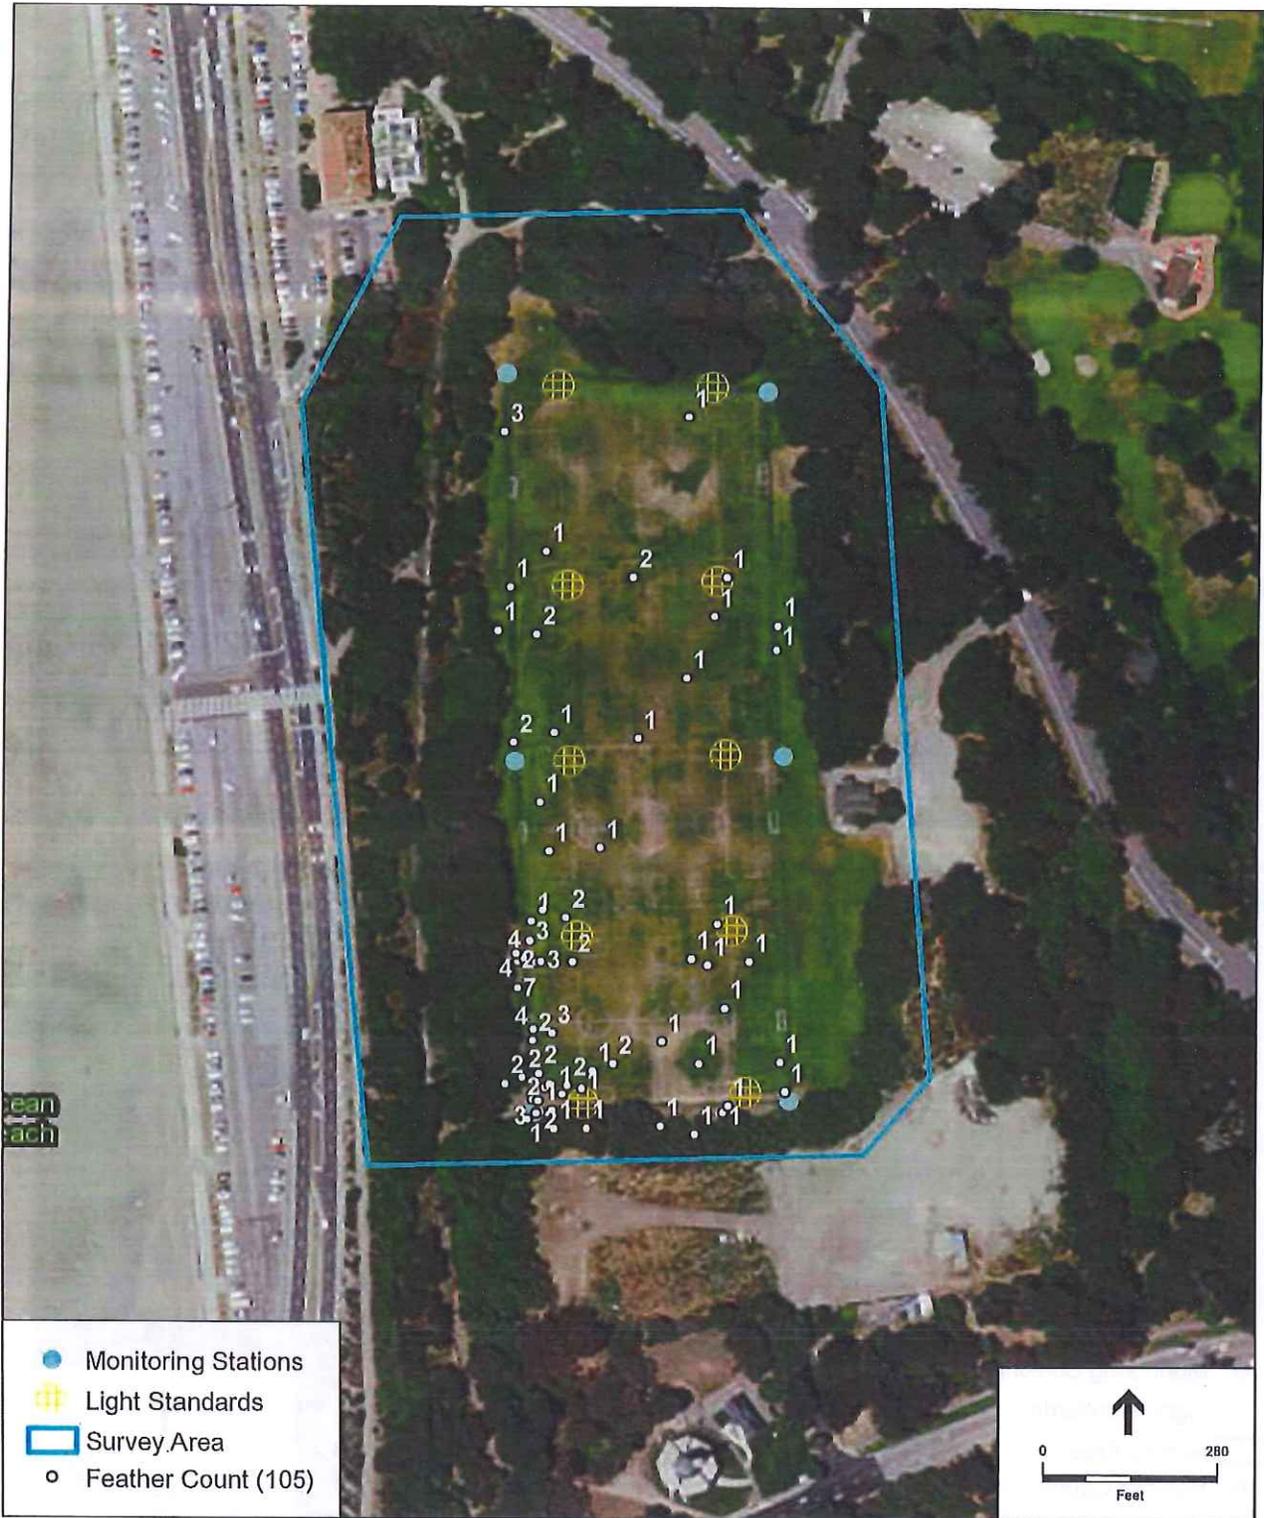
A total of 40 feathers were observed on the athletic fields during the morning sweep. Each feather was photographed in context of the nearest light pole and up close with groups of feathers documented together. GPS data was also taken and the feather was collected. **Figure 1** depicts the location of feathers or groups of feathers collected during the survey.

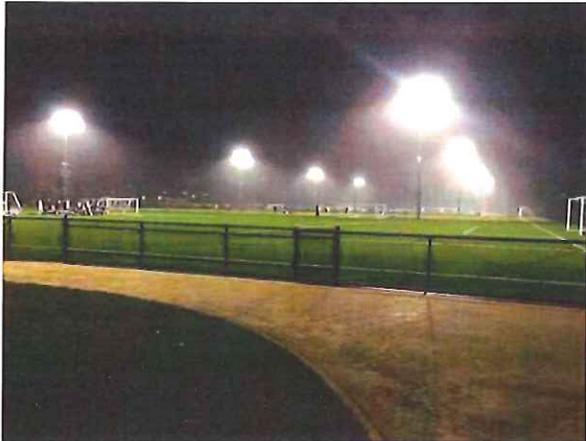
**Photo 1:** Athletic field lights in-use.

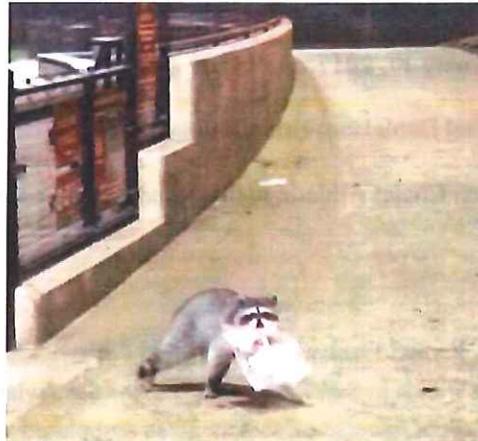
All fields in-use upon ESA's arrival and human noise and activity was high throughout the survey period. After last light, avian activity over or on the margins of the fields was difficult to see beyond the glare of the field lights. Surveyor often backed away from the monitoring station to achieve a better perspective of the fields above and below the lighting. One raccoon was observed scavenging trash bins on the north side of Pitch 4.

**Photo 2:** Raccoon scavenging food waste from field trashcan.

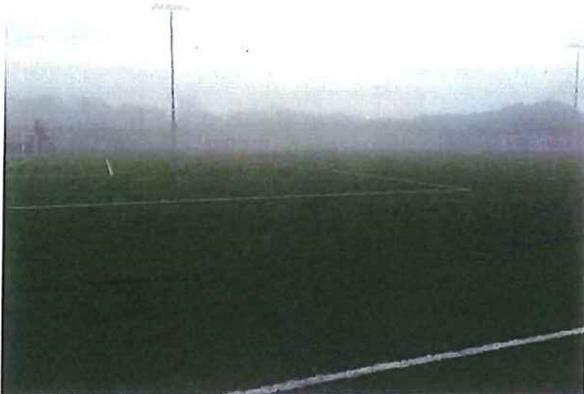
Oct 19, 2016, 7:11:09 AM

**Photo 3:** Athletic fields in morning fog.

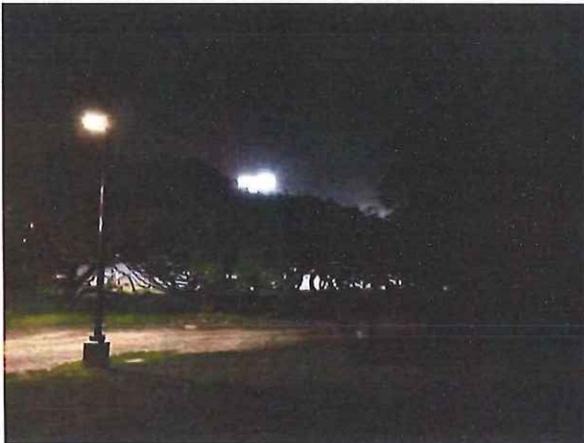
**Photo 5:** Field light illumination observed west of the primary vegetation bordering the fields.
